## Slope Stabilization Systems for Accident Prevention: A Case Study of the Expansion and Improvement of the Huaruro Countryside, Arequipa

Department of Mining Engineering, Faculty of Engineering, National University of Trujillo, Trujillo 13001, Peru

The objective of the research was to implement slope stabilization systems to prevent accidents in the expansion and improvement project of Campiña Huaruro, province of Caylloma, Arequipa. The methodology used was of pre-experimental design, where slope safety was evaluated within the operational jurisdiction of a mining company in high-risk sectors such as Belén, Paclla, Malata and Huaruro, based on risk maps and detailed observation. The results indicated that the systems implemented were cable-reinforced meshes for dacite rock and dynamic rockfall barriers designed for the type of andesite rock present in the project slopes. In addition, the IPERC revealed that the risk levels for the tasks performed on the slopes were 25% moderate risk and 75% low risk. As a result of these preventive measures, a reduction in the accident rate was achieved in the Huaruro project, decreasing from 17.36 to 5.20, which represents a difference of 12.

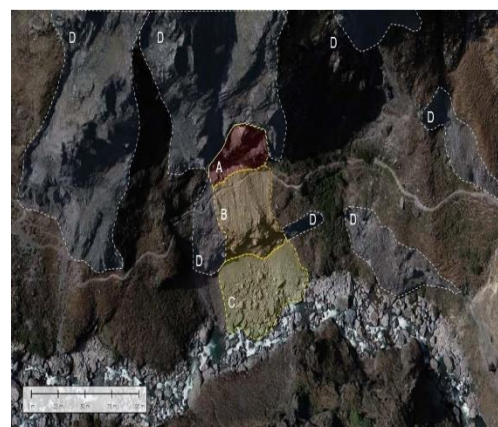
Figure 4. Orthophoto of the landslide zone (progressive 0+500)

The study began with an exhaustive geotechnical diagnosis of the slopes, focusing on topographic and geomorphological characteristics including slope angle, rock type and material stability. Figure 4 illustrates in detail the zones of detachment (A), transport (B), accumulation (C) and areas where rockfall events were previously initiated (D). Zone A is the elevation of the access road in this sector with an altitude of 2935 msnm, the width of the landslide measured at the road crossing was 50 m, the collapse trajectory initiated from a near vertical ( $>85^\circ$ ) upper rock massif wall with a steep rock slope ( $40^\circ$  slope and 55 m long), the distance measured from the head of the main escarpment to the foot of the accumulation zone is approximately 200 m, with an average slope of 55 degrees. Zone B has a thin layer of coarse colluvial material, the material being extremely loose and erodible, especially when

disturbed. Zone (C) are slope zones that are produced by accumulation of material and zone (D) are source zones where previous rockfall events were initiated.

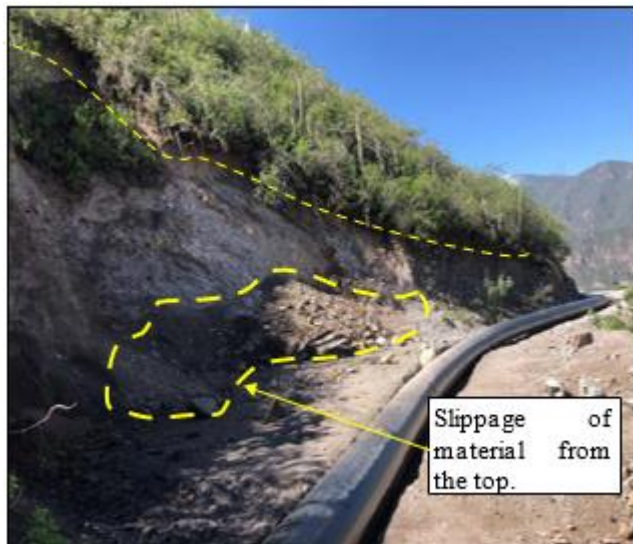
**Figure 6.** Slope in sector 7+930 - 7+960 in section 2

Figure 6 shows the diagnosis of the slope in sector 7+930 - 7+960 in section 2, where a deep slope cut of the quarry excavation is observed, it presents subvertical cuts and monitoring is recommended, as well as signage to restrict access.

In sector 7+930-7+960, the slope is unstable due to the subvertical cut that was the result of the excavation of the quarry to fill the material. In sector 8+270-8+290, the slope has fallen rock fragments because of the earthquake and in sector 10+210-10+260 the slope is currently being cut and fragmented for the axis of the pipeline.

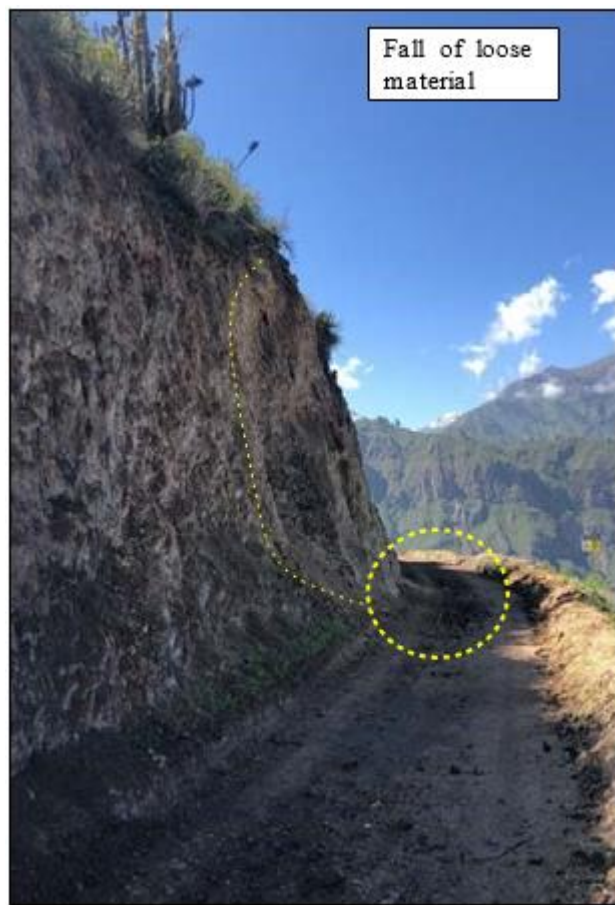
**Figure 7.** Slope in sector 8+270 - 8+290 in section 2

Figure 7 shows recently detached material in sector 8+270 - 8+290 in section 2, where there is a cut in the slope because of excavation for the pipeline shaft, material falling to the ground because of rainfall, landslides, and possible seismic events, indicating the need for constant monitoring to detect any signs of emerging instability in the slope.

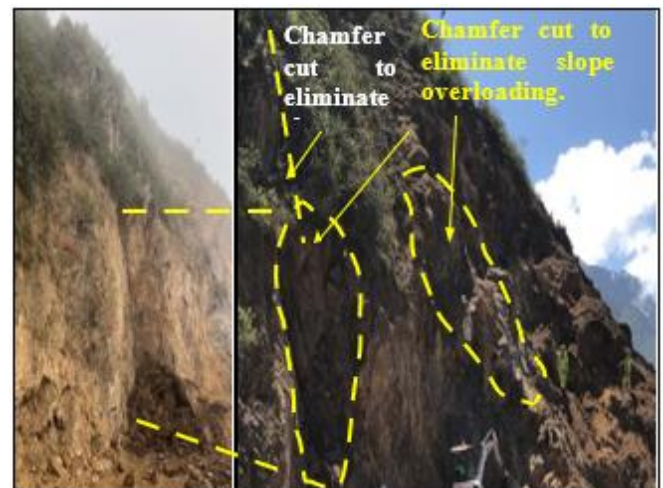
**Figure 8.** Slope in sector 10+210 - 10+260 in section 2

The analysis in sector 10+210 - 10+260 in section 2, shown in Figure 8, shows the slope cut as a result of the excavation for the pipe axis, rock fragmentation, fractured and altered material with simple compressive strength of 5 to 25 Mpa, where it is recommended to remove the material and remove the upper part of the overburden, making a 45° chamfer cut, as well as cutting the altered material at (0.33H:1V) in the subvertical cuts.

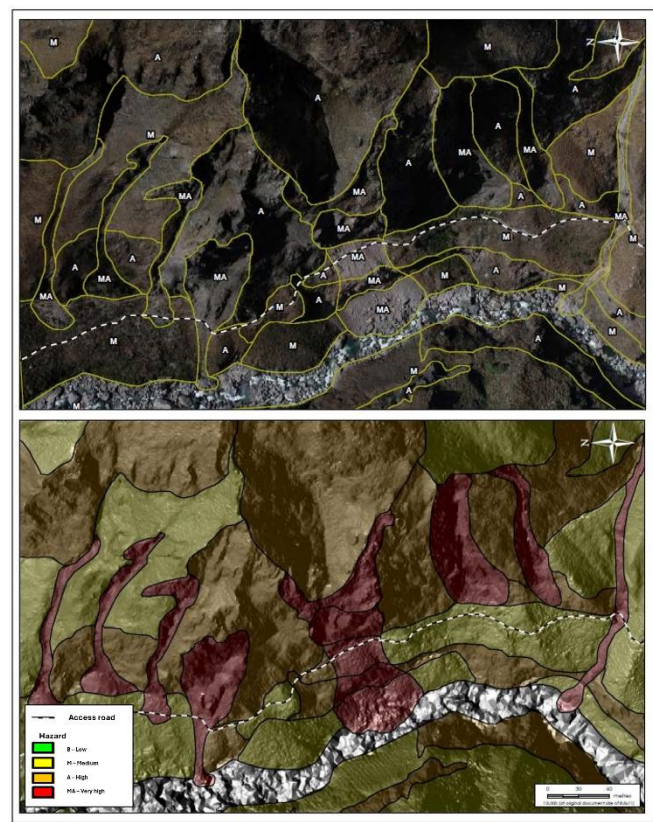
Figure 9. Hazard map in interest (progressive 0+200 to 1+200)

Based on geologic mapping, field observations and slope characteristics, analyses indicate that rock falls are mainly attributed to the intersection of discontinuities and formation of a blocky rock mass structure, where the failure modes are mainly wedge and planar instabilities with overturning associated with subvertical discontinuities in favor of the slope. Several rocks located in the landslide detachment zone (zone A) have been observed to be unstable, with very high rockfall hazard. These boulders vary in size from  $\sim 0.5 \text{ m}^3$  to  $\sim 2 \text{ m}^3$ . Likewise, there are localized areas that have blocks or groups of blocks, with volumes greater than  $100 \text{ m}^3$ . There are also landslide types: Low (B), flat to undulating topography, with minor mountainous parts, the terrain shows no evidence of previous landslide activity. Medium (M), slopes with old evidence of landslide activity, but which have not shown movement in the last 100 years. High (A), steep and abrupt relief, slopes frequently subject to landslide activity, landslide activation results when events with recurrence intervals of less than 10 years occur. Very high (MA), very steep and rugged relief, slopes with fault zones, intensely weathered and/or altered, saturated and highly fractured rock masses, actively

sliding slopes, movements may be continuous or stationary (see Figure 9).

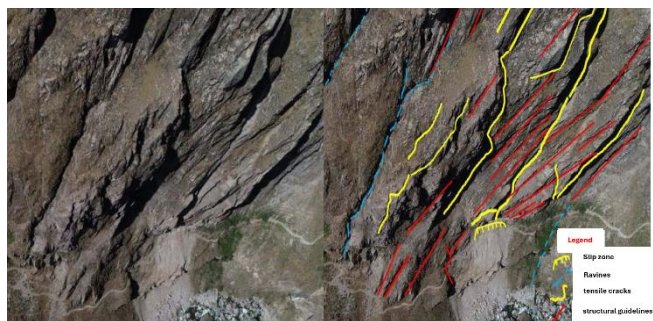
Figure 10. Landslide zone and geological structures

Locally there is the presence of diagonal fracturing with an inclination of approximately 90°, structurally they could be local geological faults, but their formation and deposition of the volcanic rock formed columnar structures of columnar disjunction type, where the degree of fracturing consists of vertical openings. Figure 10 shows the most important and

longest structures in the work zone, where very steep slopes to verticality are observed, presenting unstable blocks and structures in the form of vertical columns.

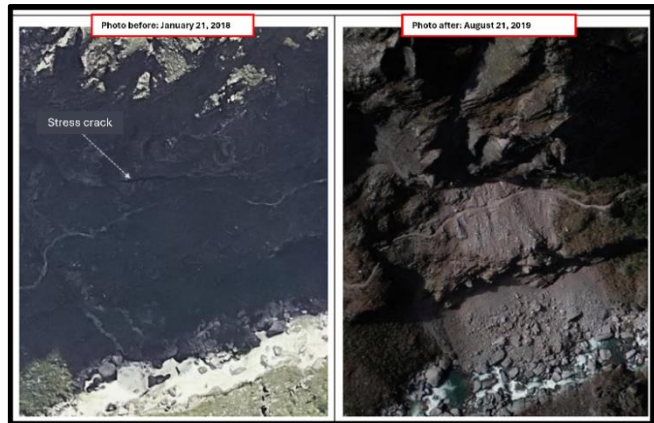
Figure 11. Level of weathering in the research area

Some causes of triggering factors are the high level of weathering, presence of multiple faults and tension cracks which facilitate water infiltration and weaken the rock mass structure. Along the slope there is the presence of differential disintegration and erosion along the andesite and dacite contact zone (see Figure 11). The area investigated is characterized by high seismic activity. According to records of the Geophysical Institute of Peru (IGP), in the first three months of 2019, 11 earthquakes with magnitudes between 3.4 and 5.4 were reported within a radius of 100 km from the study site.

The diagnosis showed that the topography is very steep, with an average angle of more than 85 degrees in the landslide zone. High level of weathering of local rocks including the presence of multiple faults and fractures with vertical and subvertical dip orientation facilitating rockfall. The presence of a geological contact (andesite rocks on top of dacite rocks) characterized by very high weathering, with loss of shear strength. Occurrence of heavy rainfall episodes in the days and hours prior to the collapse, and the presence of a preferential flow of surface water in the direction of the unstable zone. Variable accident rate between 2018 to 2021, with a range of 3 to 8.
