# THE NEW SISMIMUR PLAN: SEISMIC URBAN PLANNING IN THE REGION OF MURCIA (SPAIN) AFTER THE EARTHQUAKE OF MAY 11, 2011

S. GARCÍA-AYLLÓN & A. TOMÁS

## ABSTRACT

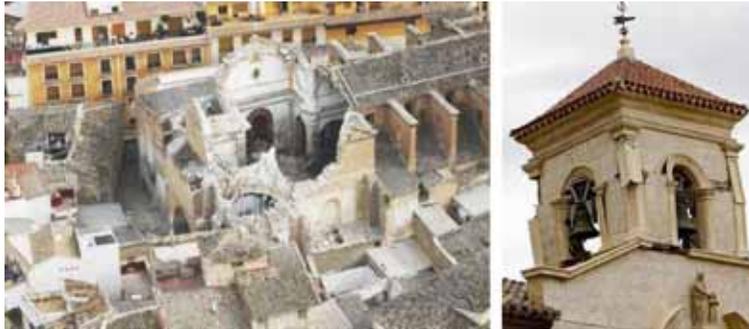
Figure 2: Historical buildings damaged in Lorca. Source: Authors.

This historic urban plot was one of the most damaged by the earthquake (Fig. 2). Such a situation can be considered somewhat predictable. The old town of Lorca was composed mainly of stone wall structures with wooden floors. Thus, there was no diaphragm effect in these structures to make them more rigid.

In the case of Lorca, where the value of  $D_m$  would in theory be between 3.5 and 4.5 for the old town [2], we note that in the plot of historical and noteworthy buildings such as churches, and a part of the 19th century plot, the buildings have brick masonry that improves the embedding between wall planes and reduces the mass of the building. These are therefore considered as less vulnerable than traditional masonry buildings. This, however, did not prevent many of them from collapsing during the earthquake of moderate intensity in 2011 [1].

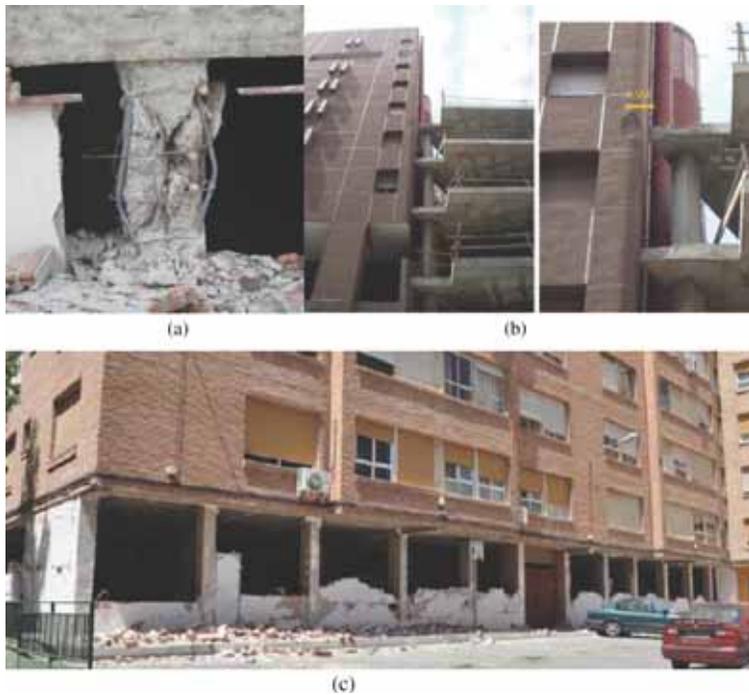
However, the most common structural pathologies in the Lorca earthquake did not generally come from bad calculation or poor execution of the structure. Besides the mentioned damaged walls and parapet detachments, the most common phenomena in buildings damaged because of the earthquake were short columns, soft floors, and pounding (Fig. 5).

Figure 5: Damage from (a) short columns, (b) pounding and (c) soft floors. Source: Authors; Cartagena Fire Department.

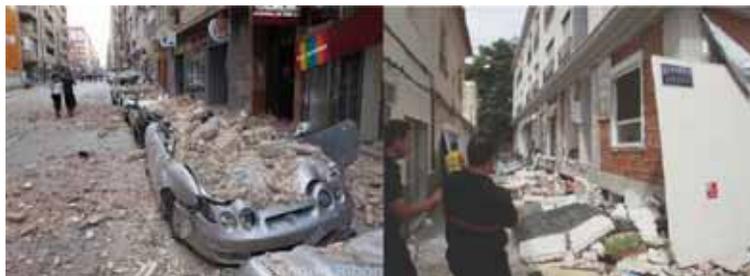
Figure 6: Detachments due to lack of bracing parapets as recommended by NCSE-02 (left) and inefficient building design (right). Source: Andrés Ribón; Authors.

These issues, shown up by the earthquake, respond to reasons related to inadequate design of the building or lack of implementation of some of the constructive recommendations of the seismic standards (Fig. 6). Nevertheless, we also find unexpected derivatives in the damage analysis such as the existence of urban planning, which did not take into account the seismic vulnerability of the city of Lorca, placing buildings on unsuitable land, on complex orography, or with unsatisfactory distances between buildings.

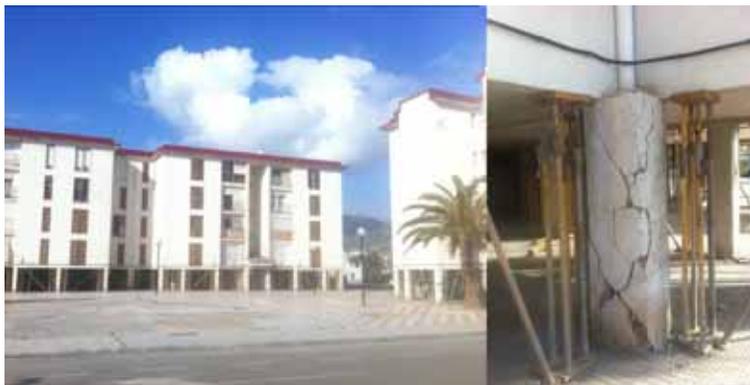
The San Fernando district was a neighbourhood with 232 homes [7] consisting of nine buildings built in the 1970s (Fig. 9). The existence of land fillings composed of sedimentary deposits from the Guadalentín River with amplification factor  $C = 1.98$ , and the existence of soft story buildings that favoured the phenomenon of ‘soft floor’, caused severe damage, forcing all nine buildings of the district to be demolished (Fig. 10).

Figure 10: San Fernando district after the quake (left) and state of the columns on the ground floor (right). Source: Authors.

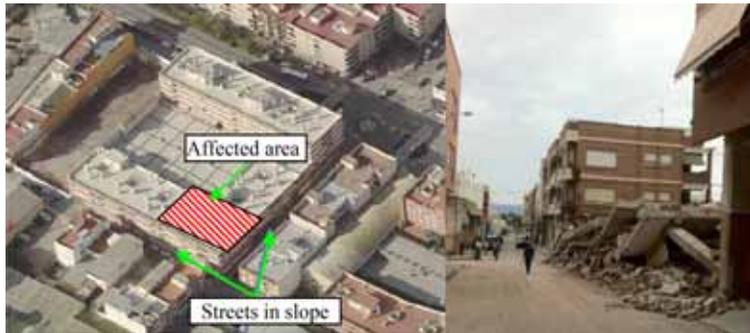
In the case, for example, of the only building that collapsed during the shock (a building which was only eight years old, and therefore theoretically adapted to the latest seismic code), the cause of the collapse has been attributed to the existence of short columns in its base. However, this configuration of short columns is the result of an urban design forced by the layout of the streets in a recent expansion of the city (Fig. 12). The sloping design of the streets and the existence of garages on the ground floor generated columns of

Figure 12: Location of the building collapsed in the neighbourhood of La Viña (left) and view from the beginning of the street after collapsing (right). Source: Authors.

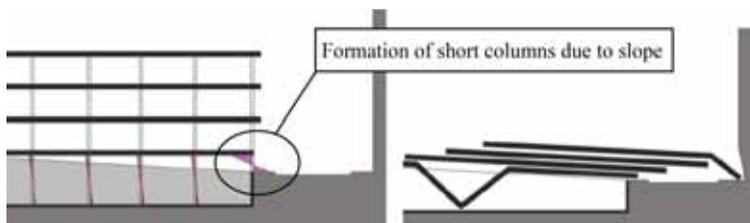
different heights on the ground floor (Fig. 13). These columns, extending from the concrete walls of the garage, included a short space where significant deformation tensions were concentrated due to the accumulation of shear stresses. This situation created a space of weakness in the ground floor that proved to be fatal during the earthquake, making the building collapse. This hypothesis is underpinned by the analysis of adjacent buildings to that which collapsed. Those buildings located in the same sloping streets suffered from the same pathologies as the collapsed one, with their short columns being close to collapse (Fig. 14).

Figure 13: Schematic formation of short columns (left) and collapse of the building (right). Source: [1].

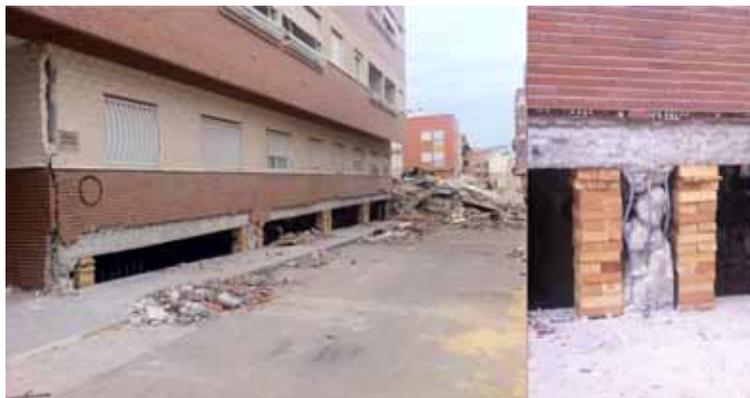
Figure 14: Situation of a building next to the collapsed one (left) and status of its short columns (right). Source: Authors.

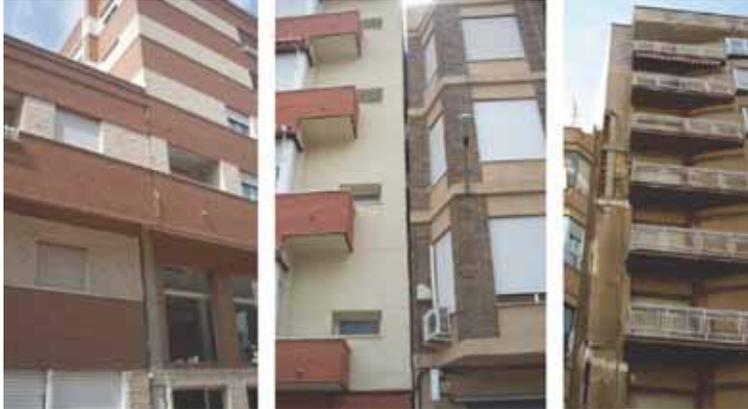
There are also other conditions which arose in the earthquake with urban origins such as pounding or the interaction between buildings because of the different resonance frequencies generated by the differences in height (Fig. 15). The conformation method of the urban plot must therefore be a variable to take into account in seismic planning, in the same way that urban management tools have to implement seismic guidelines in their content.

Figure 15: Different cases of buildings in Lorca with pounding and interaction between buildings due to height difference. Source: Authors.

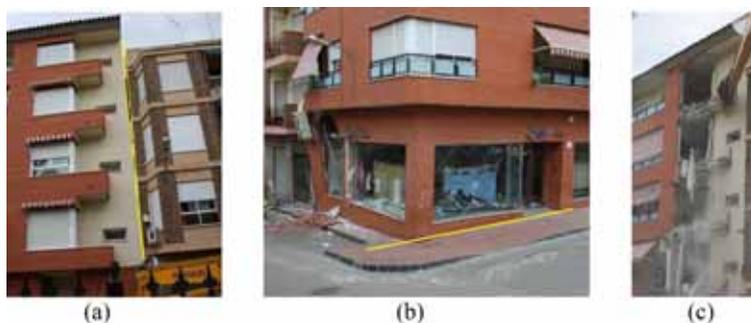
Figure 16: Condition of Grial building after the earthquake. (a) Separation of joints. (b) Settlement of foundations. (c) Start of enclosure demolition. Source: Authors, [9].

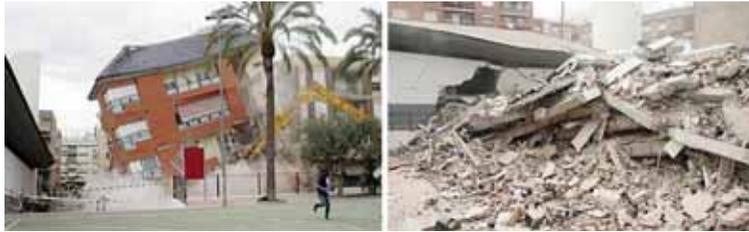
This heterogeneity of actions and the lack of standardized protocols for assessing damage were evident during the days after the earthquake in Lorca. The diversity of the criteria when cataloguing the level of damage and safety of each building gave rise to dangerous situations. An obvious case of this problem was the allegedly controlled demolition of the building called Grial in the neighbourhood of La Viña (Fig. 16). The building had, according to the rapid assessment report post-earthquake, various damages motivating its financial ruin. However, the report did not contemplate the possibility of an imminent collapse, allowing a traditional demolition that prompted the collapse of the building at its start-up. This unexpected incident destroyed a nearby church and seriously endangered the lives of the workers (Fig. 17).

Figure 17: Unexpected collapse of the building (left) and fall onto the nearby church (right). Source: RTVE.
