Oxidation Damage Analysis of Ferritic Alloy Steel Heater Tubes in Catalytic Reforming Unit

<https://doi.org/10.18280/ijht.420204>

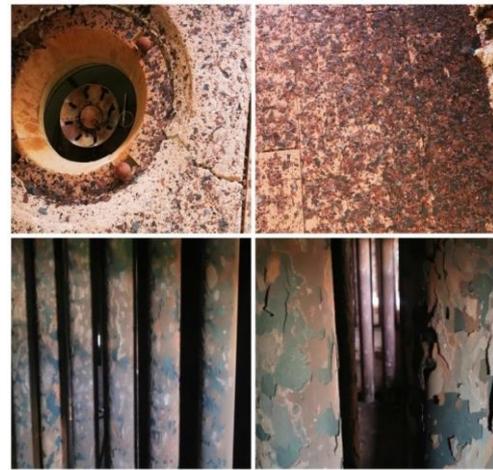
Visual inspection revealed that the radiant heater tubes have severe scale layers and are fragmented by thermal oxidation. It is illustrated in the photograph in Figure 3, taken from different areas of the fired heater.

Figure 3. Inspected radiant tubes

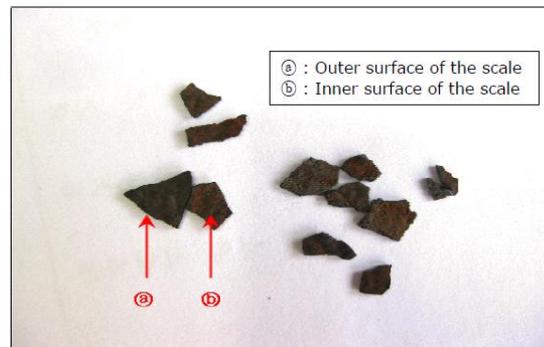
The Figure 4 represents the dark-scale fragment samples that have been taken from reforming unit heater tubes at the Skikda refinery in Algeria. Sample A corresponds to the outer surface of the scale, while sample B corresponds to the inner surface of the scale.

Figure 4. Dark scale fragment samples taken from the heater tubes

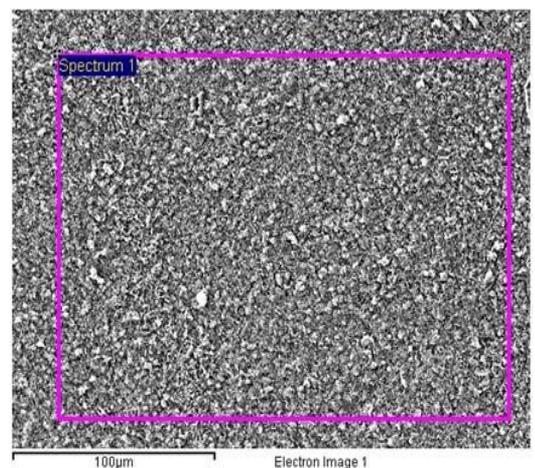
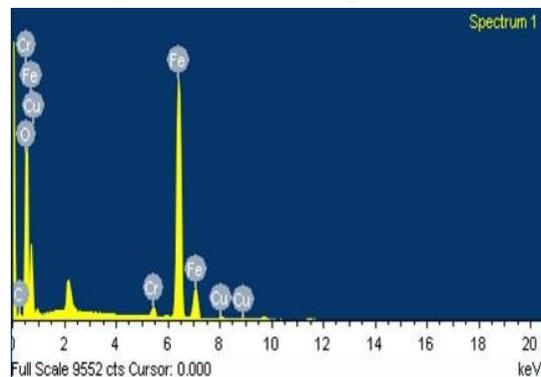
Figure 5. Energy dispersive spectrometer results from sample A of spectrum 1

For the two samples (a) and (b), we observe that five (05) peaks correspond to the existing elements (C, O, Cr, Fe, and Cu), of which we notice the appearance of a peak with a high intensity, which refers to the main element (Fe), whose mass percentage is between 66.54% and 66.77%, which aligns with the expected composition for ferritic alloy steel.

The second element in the quality of importance in mass percentage is oxygen (O), whose values revolve around 28, with a slight difference between sample (a) and sample (b) and between the same sample spectra. Oxygen is not explicitly listed in the ASTM Grade composition; its presence in the EDS analysis likely originates from the oxide layer formed on the surface of the material.

The carbon content is higher than the range specified by ASTM in the area that corresponds to the spectrum of the sample (a), with a value of 2.64 in mass percentage and lower values in the other spectra, suggesting potential contamination or variations in carbon content due to factors such as processing conditions or environmental exposure.

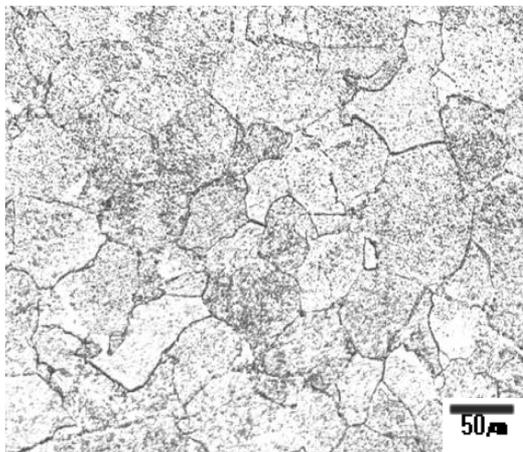
Figure 9. Microstructure of the tube A-37

Transformed large spheroidal Fe₃C carbide participates are observed in the above microstructure. Fe₃C carbides in grain boundaries are coarsened. The degradation degree of tube A-37 is evaluated as being in grade D. We can observe that there is no detection of creep cavities, micro-cracks, inclusion, or segregation. The tube is not carburized.

8. Pay special attention to severe partial thermal oxidation and wall thickness reduction by localized corrosion in every periodic inspection, and recheck after 2 years with a replica test.

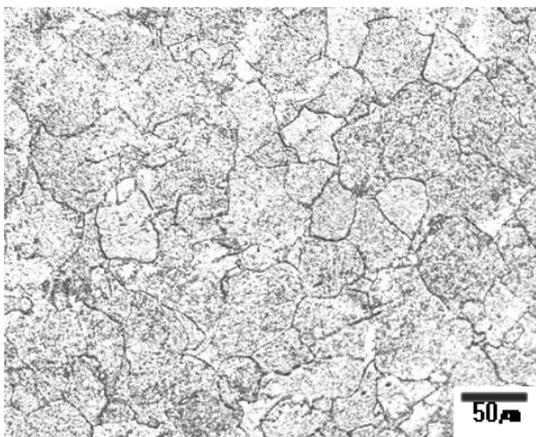
Figure 10. Replica test results of the tube B-37

The above microstructure shows structures mixed of ferrite and pearlite phases. Fe₃C carbides decomposed into small particles and precipitated in grain boundaries. The degradation degree of tube B-37 is evaluated to be in grade C. There is no detection of creep cavities, micro-cracks, inclusion, or segregation. The tube is not carbonized. We can conclude that the radiant heater tubes are not carburized. The degradation degree is in grades C and D. The residual life is 40~60%.
