Barrier Failure and Fire Escalation in a Non-Class Wooden Fishing Vessel: A Structured Safety Assessment of the Hentri-I Engine-Room Fire

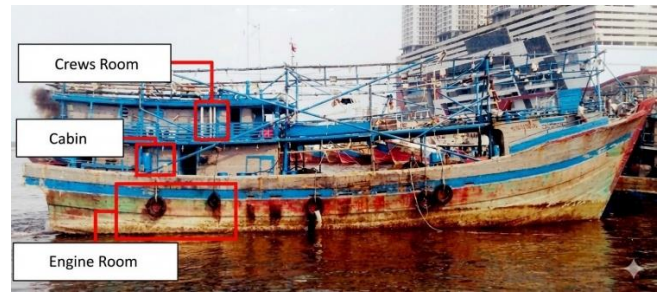
Figure 2. General view and baseline profile of Hentri-I (wooden, non-class fishing vessel)

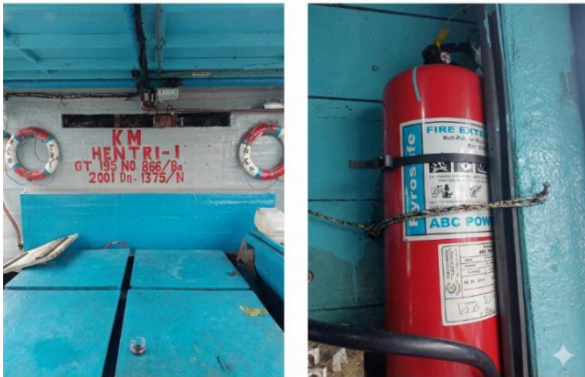
Suppression capability was limited to portable extinguishers without a dedicated fire pump/hose attack capability or a fixed machinery-space system (Figure 3). This configuration reduced sustained cooling/blanketing potential and increased

The onboard firefighting and survival equipment observed in the case is documented in Figure 3, which provides visual confirmation of the portable-only suppression posture and the practical limitations of first-response capability when machinery-space conditions escalate. This evidence supports the interpretation that portable extinguishers functioned as the sole active suppression option, with limited redundancy and no infrastructure to sustain prolonged firefighting once access became unsafe.

Figure 3. Firefighting and survival equipment observed onboard (portable extinguishers and lifebuoy arrangement)

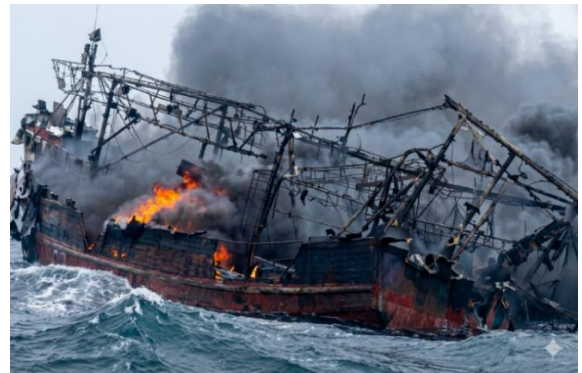
Figure 4. Vessel condition during survivor evacuation, illustrating post-escalation damage consistent with loss of compartment control

Consequence-side evidence is synthesized using Figure 4, which captures the evacuation context and the physical signs consistent with loss of compartment control and severe escalation. To translate this evidence into engineering-actionable inferences, Table 4 summarizes the barrier-to-outcome linkages derived from the case record, showing how prevention, detection, suppression, and consequence-management degradations coherently align with the observed survivability trajectory.
