AN EXPERIMENTAL STUDY ON ALTERNATIVE CFRP RETROFITTING APPLICATIONS OF HERITAGE STRUCTURES

N. TORUNBALCI, E. ONAR & F. SUTCU

Faculty of Architecture, Istanbul Technical University, Istanbul, Turkey.

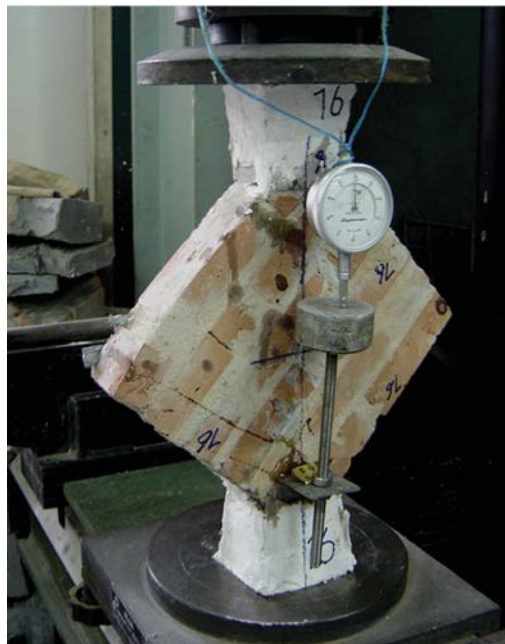
Figure 1: Brick wall specimens and test set up.

The experiments consisted of three series with six brick wall specimens of size 185 mm × 185 mm × 45 mm provided for each series. Six brick wall specimens were used without strengthening as an additional series to represent unreinforced masonry (URM) walls. Displacements are measured by a transducer placed at 100 mm nominal length as shown in Fig. 1.

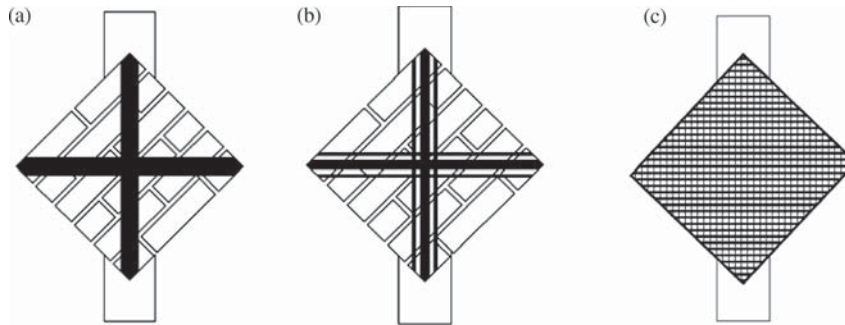
Figure 2: Strengthening types: (a) Series I – CFRP stripe, (b) Series II – CFRP apart-stripe and (c) Series III – CFRP textile.

In Series I, ready-made 25 mm wide laminated CFRP strips are applied first in the direction of the tensile stresses and then compressive stresses of brick wall specimens (Fig. 2a).

In Series II brick wall specimens, the laminated CFRP strips are again applied first in the direction of the tensile stresses and then compressive stresses of brick wall specimens. For this case, however, 0.5 cm wide CFRP strips are used at a distance of 1 cm on both sides of CFRP strips of 1.5 cm width to provide a further spread reinforcement effect on a wider wall surface and is referred to as 'apart-strip FRP' in the study. The purpose here is to cover a wider surface with the same quantity of the strengthening material compared to Series I (Fig. 2b).

For Series III, however, a 165 μm thick unidirectional fabric sheet, namely textile CFRP is used. The textile CFRP is a cheaper material than the laminated CFRP and, therefore, the application of textile CFRP is performed in order to keep all the cracks to be formed on the surfaces of the brick wall specimens under control (Fig. 2c).

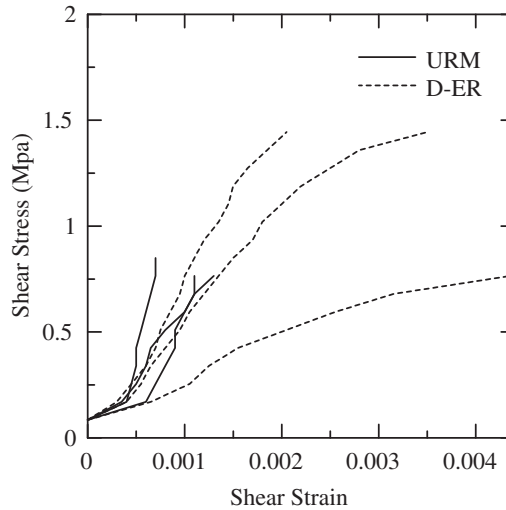
Figure 3: Shear stress–shear strain relation of unreinforced and repaired wall specimens.

where w , h and t are the specimen width, height and thickness, respectively, and n is the percentage of the area of the unit that is solid, as a decimal. Average maximum strengths of the URM walls subject to loading and after repair by the epoxy materials following pre-damaging are determined as 0.79 and 1.22 MPa, respectively. Results are shown in Table 2, where COV represents the coefficient of variation. It was found that the displacements of the URM walls are increased twice as much following the epoxy repair. The shear stress–shear strain diagram for URM walls is illustrated in Fig. 3.

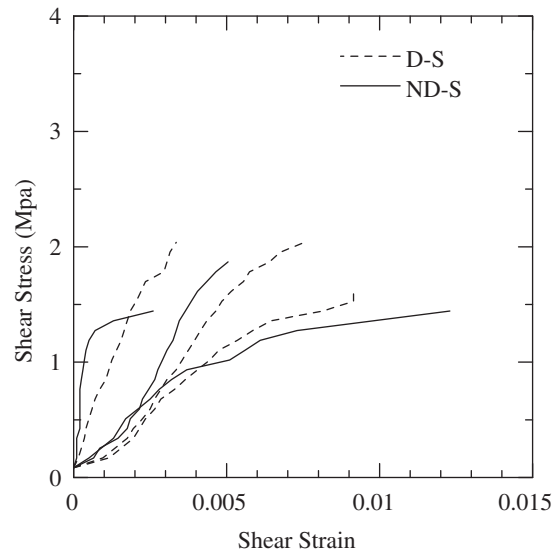
Figure 4: Series I shear stress-shear versus strain relation.

Compared with URM brick walls, the strengthening of brick wall specimens classified under Series I significantly increases the strengths of the specimens. Furthermore, the increases in the degrees of the displacement are also significant compared to that of URM specimens (Fig. 4).

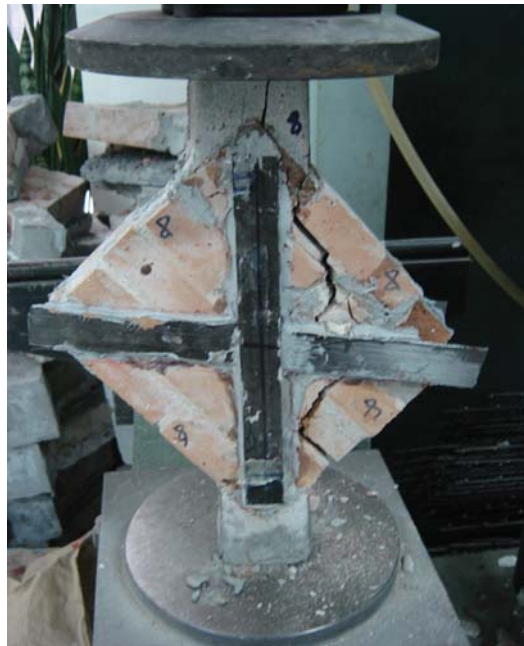
Figure 5: Series I failure mode.

For Series I specimens, the sample types exhibiting the highest failure ratings are D-S, whereas the specimen types featuring lowest failure ratings are ND-S. Based on the comparisons, it can be concluded that strengthening of the walls on one side significantly improves their performances, irrespective of whether they are pre-damaged or non-damaged. The typical failure mode of the specimens is illustrated in Fig. 5.

Prior to failure, the cracks propagate along the portion of the brick wall specimens where no strengthening is provided. In some cases, the separations are observed between FRP strips and the surface of the specimens. Complete separation is, however, not observed in any one of the specimens. Notwithstanding the occasional cases where the URM brick walls undergo instantaneous failures under ultimate loading, no fragmentation is observed for the specimens strengthened with CFRP strips.

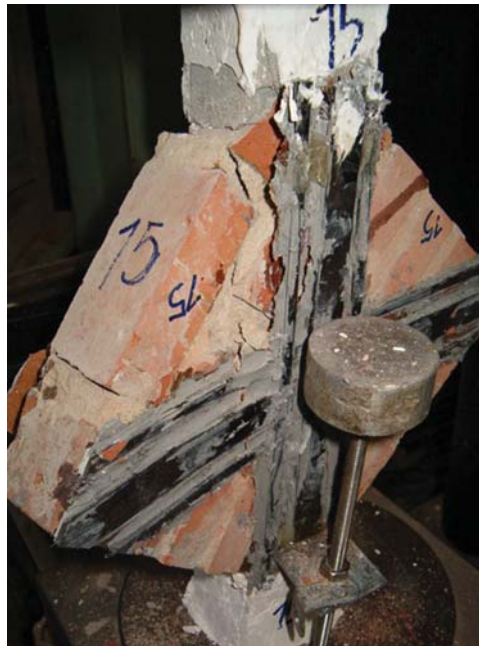
Figure 6: Series II failure mode.

The failure mode of the brick wall specimen is as illustrated in Fig. 6. Similar to the case for Series I specimens, no crack formation is observed in the portion of the specimens in Series II with CFRP, except the de-bonding between CFRP and wall surfaces in some cases. The stress–strain diagram is illustrated in Fig. 7, which provides information on the changes in the ductile behaviour of the specimens after strengthening.

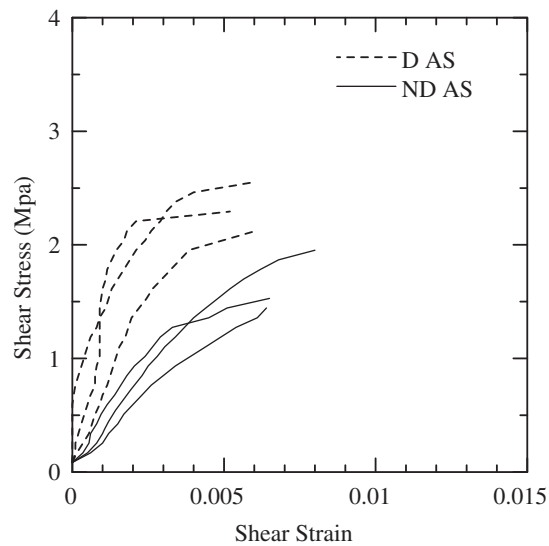
Figure 7: Series II shear stress-shear versus strain relation.

The specimens in Series II featuring the highest failure loading rating are DS-AS, whereas the lowest failure loading rating is observed for ND-AS. Irrespective of whether pre-damaged or non-damaged, the strengths of the URM brick walls are increased by 2.0–2.5 times following strengthening on one side. Compared with those in Series I, strength increases in Series II specimens imply that application of CFRP in the apart-stripe form is more advantageous.

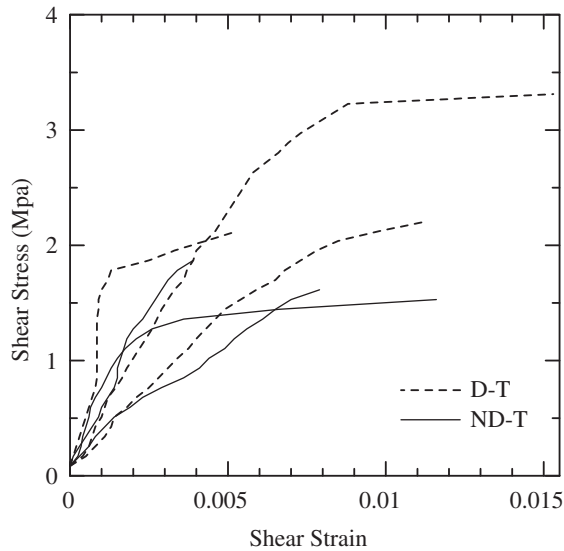
Figure 8: Series III shear stress-shear versus strain relation.

The specimens with highest fracture loading rating within Series III specimens are D-T, whereas the specimens featuring the lowest fracture loading rating are ND-T. The strengths of the specimens increase by two to three times compared with the URM walls, depending on the damage status. The shear stress–shear strain diagram is illustrated in Fig. 8.

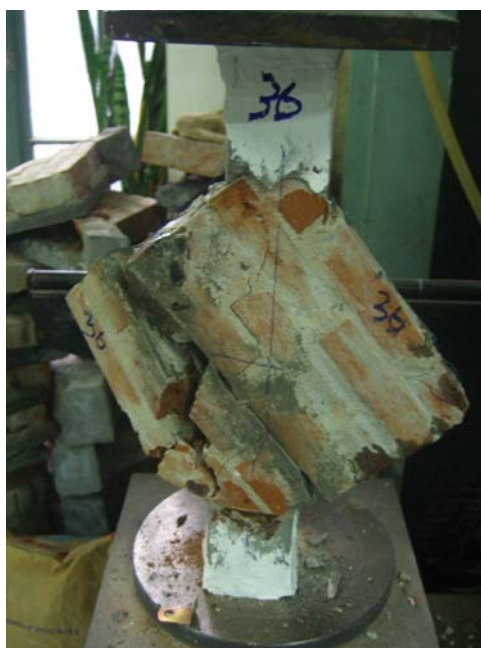
Figure 9: Series III failure mode.

It is observed that, during the failure process, the adherences between FRP textile and the wall surfaces are extremely crucial. It is concluded that the failure is induced in the brick’s internal structure. No fragmentation is observed in strengthened specimens whatsoever. As a result of the internal forces generated within brick wall specimens, they either collapse or the cracks are propagated in the bricks along the joints, which give rise to brittle fracture at failure.

As in the case for Series I specimens, the increases in the strengths of the brick wall specimens strengthened only on one side imply that such strengthening improves the specimens’ behaviour. Irrespective of the type of strengthening, the application only on one side results in eccentricity due to the asymmetrical sectional geometry, resulting in premature failure. The typical failure mode of Series III specimens is illustrated in Fig. 9.

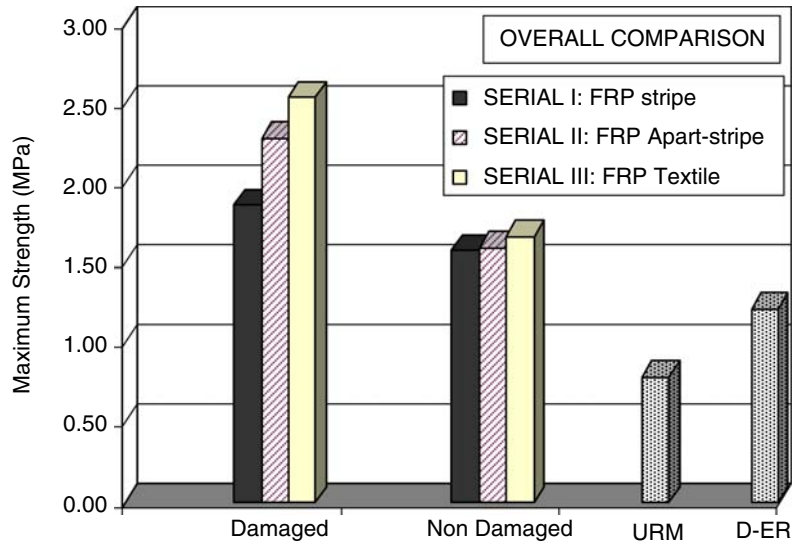
Figure 10: Overall comparison of experimental results.

fracture loading rating is achieved for D-T specimens, i.e. pre-damaged brick wall specimens strengthened by CFRP textile. The lowest failure loading rating is observed for ND-S brick masonry wall specimens, i.e. non-damaged specimens strengthened using laminated CFRP strips. With regard to the displacements, the improvements in Series III specimens are also better than in Series I and Series II specimens.

The strengths of Series II brick wall specimens turn out to be slightly higher than those in Series I. In case laminated CFRP is used, the apart-stripe form is suggested for showing better performance due to the application area extension. The maximum strength results for all experiments are illustrated in Fig. 10.

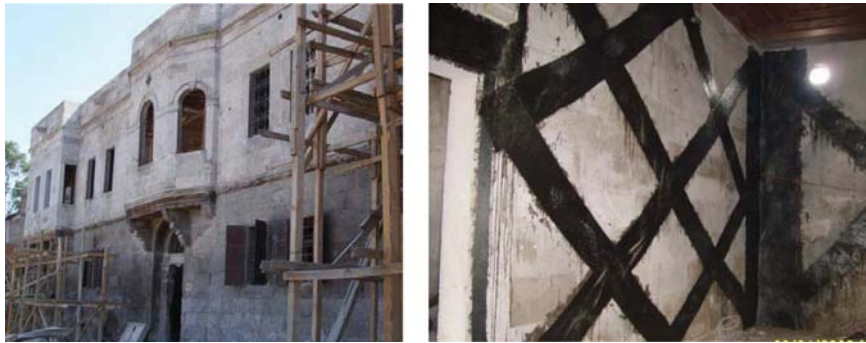
Figure 11: Front wall external view and CFRP application on the inner face.

For the repairing of cracks on masonry walls in the basement and upper floors, epoxy resin injection was used partially and for the inner walls CFRP was applied. CFRP application was accepted by the authority in charge for the inner walls and the inner sides of external walls as they were later covered with timber lining (Fig. 11).

As it is not possible to strengthen the structure from the façade, the outer walls of the buildings were strengthened on the inner face and the inner walls were strengthened on both faces with

bidirectional textile CFRP. Therefore, the masonry structural walls were protected from breaking into pieces and the strength was increased. Moreover, CFRP was also applied on the perpendicular intersecting points of inner walls which gives stronger connections at these intersections. In case the cracks are substantially wide, the strengthening was supplemented with reinforcing steel plates. Where wooden covering is not available, the cracks were repaired with epoxy resin but no CFRP was applied to preserve the original appearance of the heritage structure.
