## Study of Surface Hydrogenation Effect on Fatigue Crack Initiation in ASTM 904L Austenitic Stainless Steel Under Cyclic Loading (Bending-Torsion)

Mustafa Sami Abdullatef

Electromechanical Engineering Department, University of Technology-Iraq, Baghdad P.O. Box 19006, Iraq

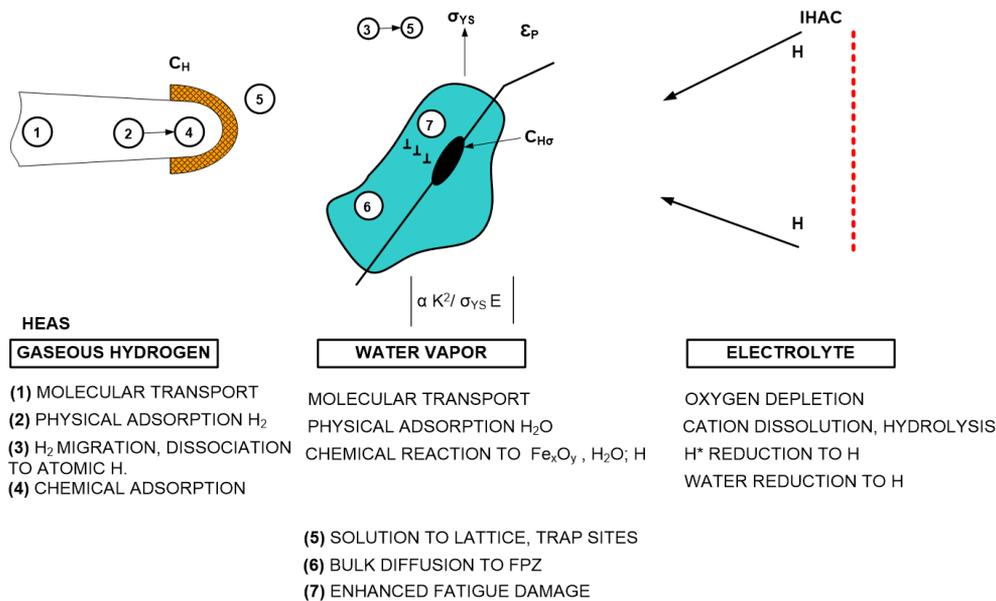
**Figure 1.** The set of atomic processes that transfer harmful hydrogen to the region of the crack tip fracture process [5]

IHAC and HEAC are similar in most respects, with the difference being the source of the harmful H given to the crack tip fracture process zone (FPZ). Figure 1 depicts this viewpoint in summary. As can be seen from Figure 1, the set of atomic processes that, during HEAC for water vapor, an electrolyte or gaseous hydrogen or IHAC for a micro-structure that has already been charged with hydrogen, transport damaging hydrogen to the crack tip fracture process zone. The plastic zone's outside limit is indicated by the dotted line. Maximum crack tip tensile stresses are proportional to  $K^2/\sigma_{YS} E$  at a distance from the tip [5].

microstructure. Subcritical fracture growth takes place then under stress, the hydrogen-charged metal, as can be seen in Figure 1's right side. Loading causes dissolved hydrogen to be transferred from the local microstructure to the process zone at the fracture tip, which promotes crack propagation. Since

Mechanical loading and chemical reaction work together to create hydrogen environment assisted cracking (HEAC), as can be seen in the left and bottom of Figure 1, most of the time, clean fracture surfaces that are confined near the tip are where atomic hydrogen is formed. H absorption into the crack tip FPZ and subsequent embrittlement come next. As demonstrated for three settings, the fracture tip surface responses are provided by mass transfer of the components of the surrounding environment that is particular to the occluded crack volume. Atomic hydrogen (H) is created, in order from left to right, by dissociative chemical adsorption for H<sub>2</sub>, chemical reactions for gases like water vapor or H<sub>2</sub>S, or electrochemical cathodic reactions for acidic or alkaline electrolytes. Once created, the H diffuses into the FPZ in front of the crack tip and causes damage. For alloys in aqueous H<sub>2</sub>S-bearing electrolytes, the hydrogen mechanism for stress corrosion cracking (SCC) and sulfide stress cracking is provided by this scenario. At the crack tip, electrochemical processes that result in metal dissolution and passive film generation may also be occurring at the same time as H production [5].

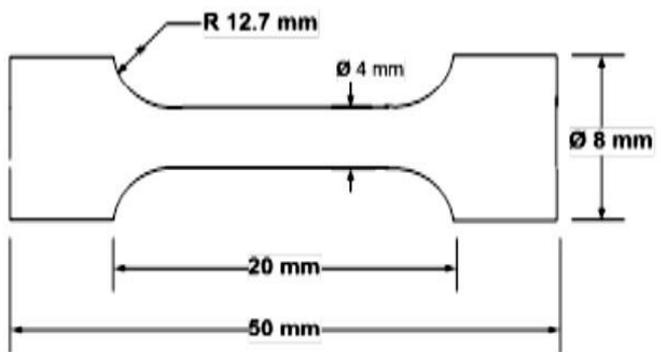
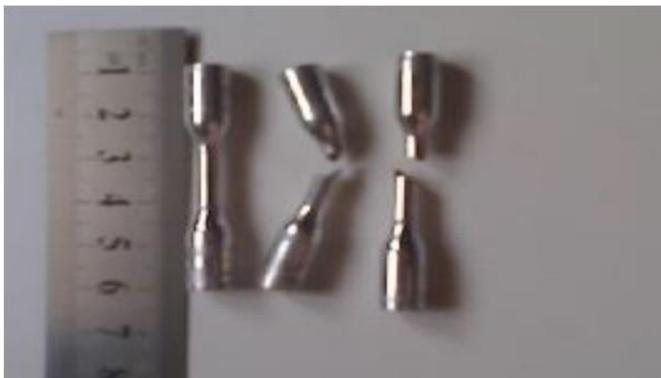
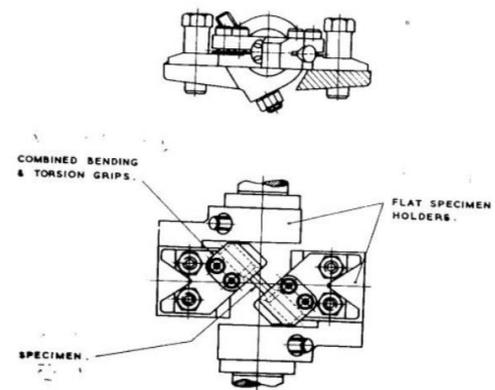
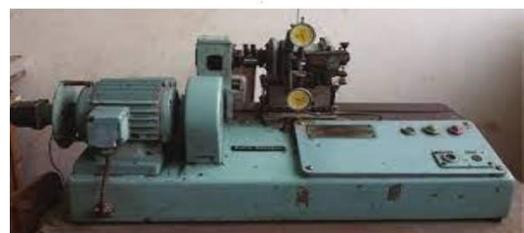
**Figure 2.** Fatigue test

(a) Avery 7305 test machine; (b) Fatigue test specimen (for combined loading bending-torsion) [15]

The Avery 7305 test machine (Figure 2b) was used to conduct the fatigue test under constant amplitude stress and stress ratio (R=-1) in a lab setting with combined loading (bending-torsion) at a frequency of 50 Hz. A scanning electron microscope (SEM) was used to inspect the lateral surfaces of the gage section at various points during the fatigue life in order to study the initiation and growth of fatigue cracks.

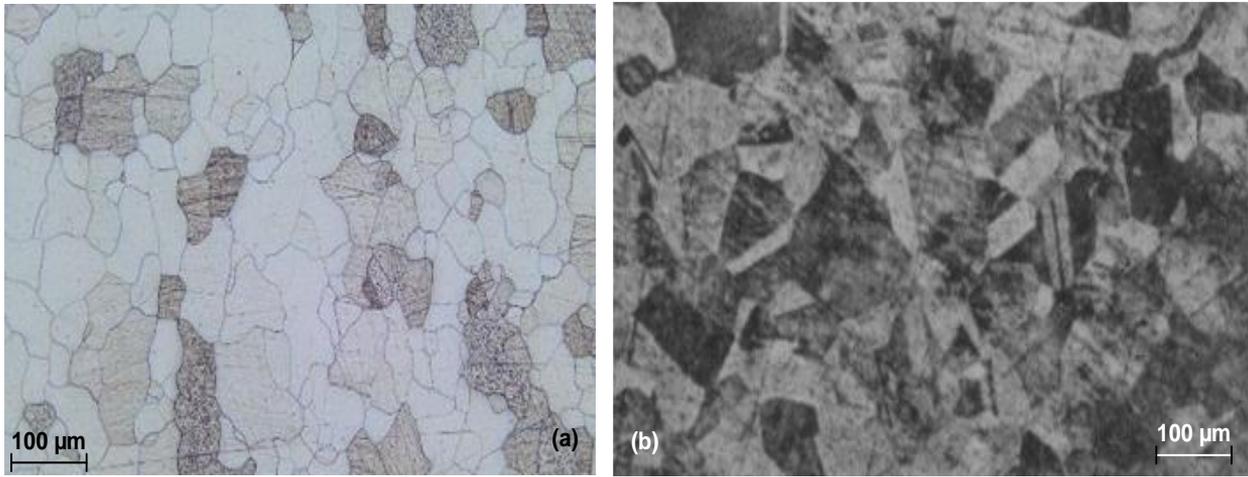
**Figure 3.** Initial microstructure of an austenitic stainless steel type ASTM 904L: a) Non-hydrogenated, electrochemically etched with 40% H<sub>2</sub>O+60% HNO<sub>3</sub>, J=500 A/m<sup>2</sup>, t=120 sec at room temperature; and b) Hydrogenated and out-gassed

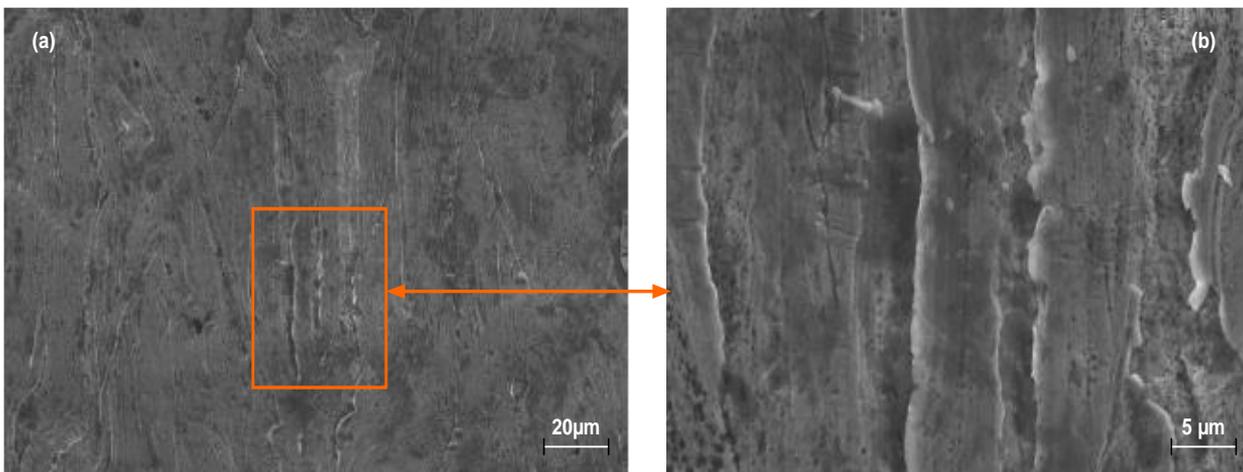
**Figure 4.** Detail of the surface at the gage surface of hydrogenated and out-gassed sample fatigued to 20% of fatigue life; subgraph (b) is an enlargement of the area included in subgraph (a)

The surface of the tired samples that had been hydrogenated and out-gassed first showed the peeling off of extremely thin coatings in a few localized areas throughout the gage section. This is shown in Figure 4a and Figure 4b, and it appears to be the result of a very weak section of the outermost surface cracking, possibly in conjunction with already existing hydrogen-induced microcracks. Due to their elevation above the surface plane in the micrographs, these fragmented patches look whiter. They appear as soon as a few fatigue cycles are applied to the material and don't really alter throughout the course of the fatigue life. Some of them finally come off the material on their own. The hydrogen-induced microcracks, however, were not seen to lengthen throughout the course of the fatigue life.

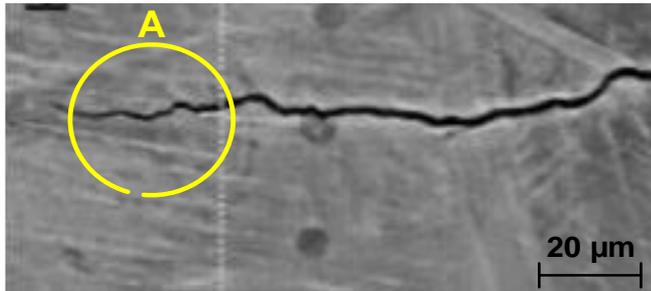
**Figure 5.** Early indication of the fatigue subsurface crack appearing on the surface of the hydrogenated and out-gassed sample at the gage surface at 50% of its fatigue life

The major fatigue crack appeared in the same region of the surface of a specific specimen used as an example in all of the samples that were observed, as shown in Figures 5-7. On the gage surface of the specimens, several dark patterns, like the one in Figure 5, were seen to develop and enlarge with increasing numbers of fatigue cycles. One of them was consistently discovered to be connected to the primary fatigue crack that caused the fracture, as seen in Figure 7. Briefly stated, the major crack initially appeared as a dark mark on the surface and developed sub-superficially. The major fatigue fracture didn't begin to manifest itself as a surface crack until the end of the fatigue life. After the sample had been cycled through 49% of its fatigue life, a photograph of the sub-superficial crack shown in Figure 5 was taken.

It is interesting to note that it spreads transgranularly, passing through grains that have and do not have hydrogen-induced surface cracks indistinctly. Since it does not follow the direction of these cracks, it cannot be assumed that it was primarily formed as a result of the deepening of hydrogen-induced cracks. The micrograph in Figure 6 was taken after the sample had been cycled for around 63% of the fatigue life and shows the same sub-superficial crack as Figure 5 but over a significantly longer period of time. The white markings (white lines) in Figures 5 and 6 show the locations of intergranular and transgranular surface fissures brought on by hydrogen. The martensitic phases (labeled A) may be seen in a few areas of Figure 5, which was magnified. Additionally, no connection between these phases and the subsurface fissures was discovered.

They may eventually both work together or individually to shorten the fatigue life. The depth of the main fatigue crack may change and become wavy, as in Figures 5 and 6. This is due to the presence of several secondary fatigue cracks. This

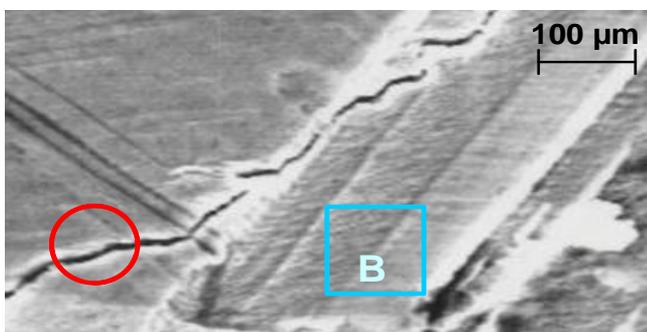
**Figure 6.** Growing of the feature associated with the subsurface fatigue crack for the hydrogenated and out-gassed specimen at 70% of the fatigue life, includes the area shown in Figure 5

Finally, the crack at the end of the fatigue life can be seen in Figure 7 in the same area that was circled in Figure 6.

explains why there are characteristics like the hump on the left side of Figure 6 that contribute to the fracture morphology's steps. Finally, it would not be appropriate to use the hydrogen-induced surface cracks as a tool to model the fatigue behavior of short cracks in austenitic stainless steels due to the intricacy of the initiation characteristics in this material.

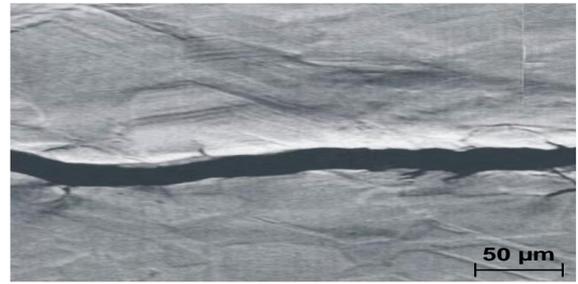
**Figure 7.** Fatigue crack on the gage lateral surface at extinguished fatigue life of the hydrogenated and out-gassed sample, corresponds to the area indicated by the red circle in Figure 6

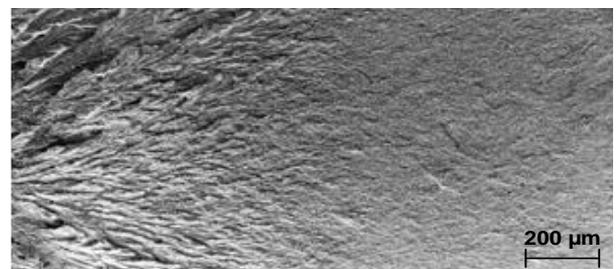
**Figure 8.** Detail of a step on the fracture surface of a fatigued hydrogenated out-gassed sample. The step corresponds to the hump on the squared region B in Figure 6

Figure 8 depicts the fracture surface in the area shown on the upper left side of Figure 6. It's interesting to note that the step on the fracture surface seen in Figure 8 exactly matches the hump in the sub-superficial crack that appears on the upper left side of Figure 6 to the left of the white circle.

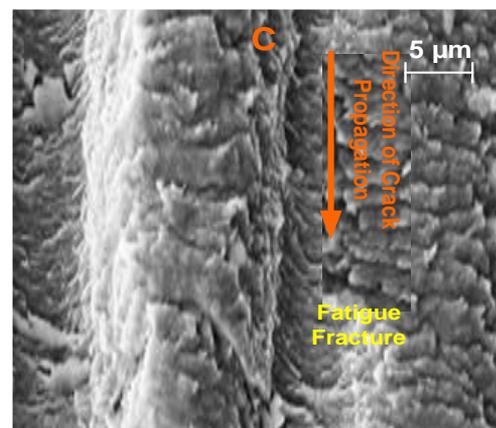
**Figure 9.** Magnification of a region of Figure 8 at the top left of the step on fracture morphology near by the lateral surface of a fatigued hydrogenated out-gassed sample (showing secondary fatigue crack, Mark C)

Figure 9, on the left side of Figure 8, shows a detail of the upper portion of this step that is closer to the sample's surface. This micrograph demonstrates the presence of secondary fractures, one of which seems to originate from a surface break that may have been caused by hydrogen (designated C in Figure 9). Observations made with a scanning electron microscope (SEM) comprised a close investigation of the fracture surfaces and the lateral surfaces of the hydrogenated out-gassed samples. Despite this, no definite evidence of the primary fatigue crack's initiation locations was discovered, most likely as a result of the very uneven fracture surfaces.

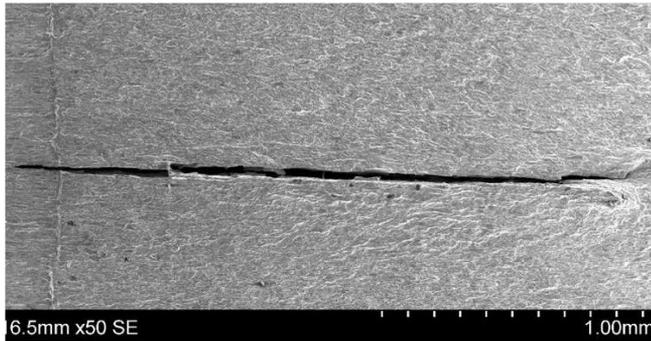
**Figure 10.** Fatigue crack on the lateral gage surface of a non-hydrogenated sample. Shows many slip marks due to the accumulated fatigue strain

A thorough investigation of the fatigue crack's initiation and propagation characteristics in the non-hydrogenated material was not one of the paper's goals. However, Figure 10 illustrates the characteristics of the propagation of the fatigue fracture in a non-hydrogenated specimen evaluated under the identical circumstances as the hydrogenated out-gassed samples for the purpose of comparison. There are numerous slide marks can be seen.

Recent research has focused on the start and spread [16-21] of fatigue fractures in austenitic stainless steels and other face-centred cubic structure materials (f.c.c) [22, 23]. It was discovered that deformation markings, along with a certain degree of surface roughness, occur early in the fatigue life and are followed by the nucleation of superficial microcracks. As the main fatigue fracture continues to merge and form, these microcracks increase in size and number. In terms of the typical creation of slip markings on the surface of the fatigue non-hydrogenated samples, the behavior depicted in Figure 10 was also documented in the literature [24-26].
