Retrofitting Mechanisms of Valuable Heritage Buildings: Al-Kifl Shrine as a Case Study

Suhaib Abbas Ali^{*}, Kadhim Faris Dhumad

Department of Architectural Engineering, Faculty of Engineering, University of Baghdad, Baghdad 10071, Iraq

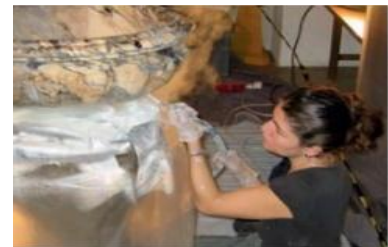
Figure 4. A portable steam cleaner used to clean decorative marble pieces [29]

- Water cleaning: Pressurized water (water jet) or spray is used, and the water can be hot or cold. This method is effective in cleaning limestone and marble, low cost, and easy to control. However, it may not be suitable for silicon stones or deteriorated buildings [32].
- Steam cleaning: Steam is used to remove dirt, sulfate scale, and some types of paint, and is useful for stone surfaces [33]. Figure 4 shows a portable steam cleaner used to clean decorative marble pieces [29].

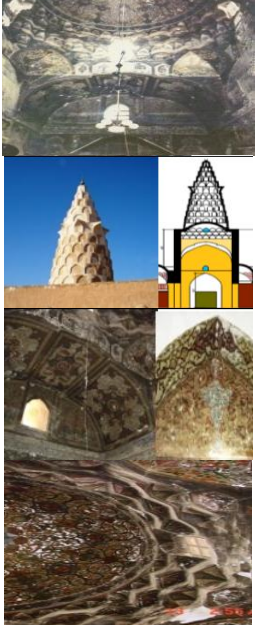
Table 3. Architectural element, type and historical period of the shrine room and the double conical Dom

Architectural Element	Type	Historical Period	Figure
The contracts	Tri-sector	The Ilkhanate

The domes	Conical	Seljuk	
Inscriptions and decorations	Geometric	Old	
Muqarnas	Botanical	The Ilkhanate

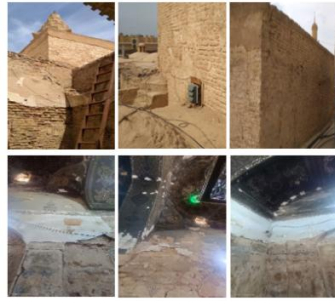
Figure 7. Natural and unnatural deterioration factors (neglect, humidity, and the effect of candles)

Environmental and climatic conditions have contributed to the deterioration of the Al-Kifl shrine. The most prominent manifestations of this deterioration include: erosion and cracking of the foundations due to rising groundwater levels and salts, and damage to the original floors due to humidity and soil disintegration. Humidity has also caused cracks and swelling in the walls, separation of stone cladding, and fading of plant motifs. Hairline cracks have appeared in the arches, muqarnas, and double dome due to earthquakes, and the external surfaces have deteriorated due to erosion and a lack of drainage systems.

Human interventions and neglect have exacerbated the deterioration of the Al-Kifl shrine, including the stability of the foundations has been affected by demolition, expansion, and neglect, and the replacement of the historical floors with modern mosaic tiles, which are incompatible with the building's authenticity. Non-specialized restoration work also

caused the covering and removal of some original inscriptions and decorations, the accumulation of carbon resulting from burning candles, and the distortion of the walls with random electrical installations.

In addition, incorrect maintenance led to the loss of the outer layer and the deterioration of the outer cover. Furthermore, the use of incompatible materials, such as the distortion of the exterior portico with modern marble, resulted in the loss of parts of the building's historical identity, as shown in Figure 7.
