Structural Behavior of Reinforced Concrete Corbels with Vertical Openings

Hadeel Sadek Mohammed^{*}, Ammar Yasir Ali[†]

Faculty of Engineering, Department of Civil Engineering, University of Babylon, Babylon 51001, Iraq

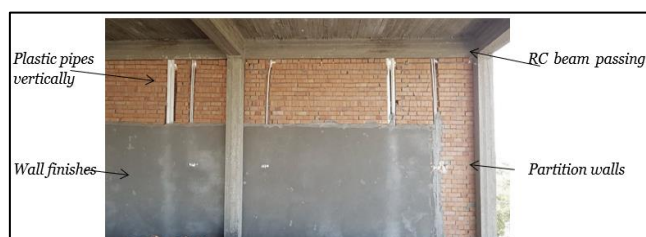
Figure 5. Vertical services pipes hidden through wall finishes (Commercial building/Babil-Iraq)

Furthermore, the majority of ducts and pipelines passing through openings of vertical in RC beams will be concealed by partitions until they reach the desired location, as depicted in Figure 5. As a result, vertical openings in RC beams have gained widespread use.

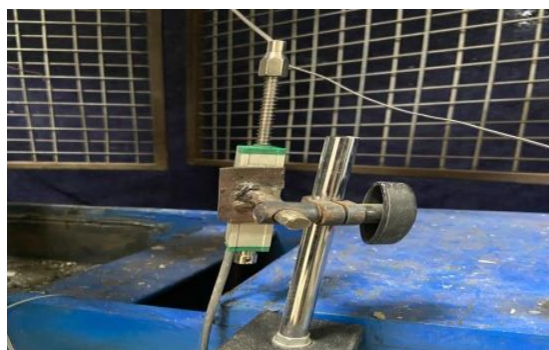
Figure 9. LVDT to measure deflection

sitting inverted position, deflections corresponding to the applied load, cracks formation and propagation. Throughout each test, instruments were used to measure how connections behave structurally at different loading stages. (linear variable differential transformer-LVDT) was utilized to measure the mid-form vertical deflection (i.e., mid-column), the concrete crack width was measure by (AEM40X, MICROSCOPE) crack meter. The load -deflection data was collected by computer system programmed by (LABVIEW) software. All device using as shown in Figures 9-11.

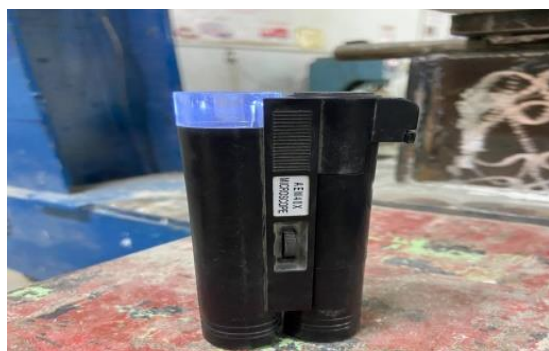
Figure 10. Crack meter to measure crack width

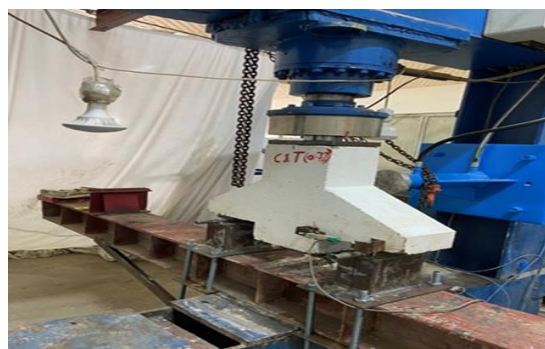
Figure 11. Test setup

The corbel-column systems were tested using servo-hydraulic actuator of 2000kN capacity exist in Karbala University's College of Engineering's structural laboratory. All samples were examined and evaluated by applied load vertically at the corbel's upper line subjected gradually and

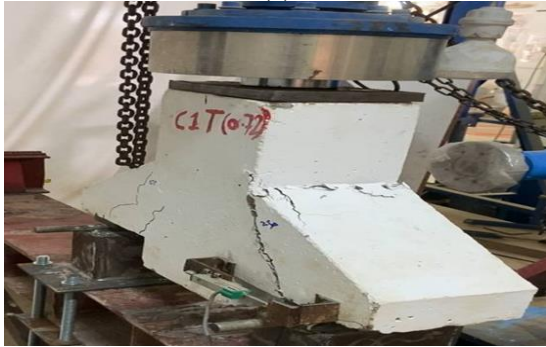
Figure 12. (a) Load-deflection of specimen C1; (b) Failure mode of specimen C1 [9]

kN, or 27% of the ultimate load, the initial crack in the corbel developed at the junction line of the column. The crack was determined to be flexural, with a maximum width of 1 mm. As shown in Figure 12(b), the fracture pattern identified the model's failure type, diagonal splitting failure, which is categorized as ductile failure. For this specimen, the number of cracks is small and the post-cracking rigidity is high.

This specimen features a corbel constructed without an opening, which is considered a reference for subsequent forms. Figure 12(a) illustrates the reinforced concrete corbel's load-deflection response at a final load of 149 kN. At a load of 40

flexural fracture, exhibited a maximum dimension of 1.25 mm, representing an increase of approximately 25% compared to the main corbel C₁. The corbel's failure commenced with the expansion of fractures on the compression strut near the corbel's aperture, culminating in failure load about 130 kN, as illustrated in Figure 14(b). Failure Mode in the specimen includes compression failure and diagonal splitting, as well as ductile failure characterized by an opening mode (frame type). A 12.7% decrease in maximum load capacity was accompanied by a 155.5% rise service deflection and a decline in post-cracking stiffness relative to the control specimen C₁.

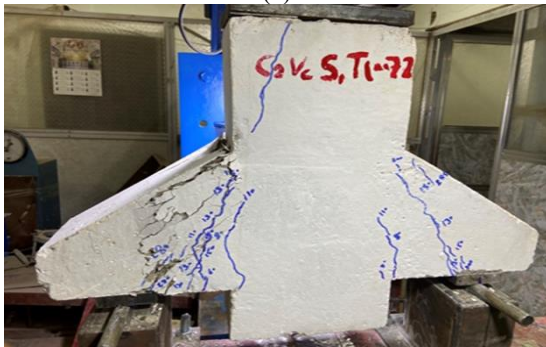
Figure 13. (a) Load-deflection of specimen C2 and C1; (b) Failure mode of specimen C2 [9]

The corbel boasts a vertical circular, tiny tangential opening with a diameter of 40 mm, situated at the midpoint of its breadth. Figure 13(a) illustrates the diagram of load-deflection relationship for this specimen, indicating a maximum load that can be applied 145.5 kN. The corbel's first fracture showed up at a load of 30 kN, which is about 20.6% of the total load. It was characterized as a flexural crack with ultimate dimension of 1.5 mm, indicating an increase of approximately 50% in contrast to the reference corbel C₁. The fissures began parallel to the vertical aperture parallel to the compression strut to the opening, and Figure 13(b) illustrates the corbel's failure mode (diagonal splitting and compression failure), ductile failure, and the collapse mechanism of the opening (frame type). When the hole was there, there were more cracks than in model C₁ (the reference model). The maximum load went down by 2.35 percent, the deflection at service load went up by 297.7 percent, and post-cracking rigidity went down compared to main specimen C₁, as shown in Figure 13(a).

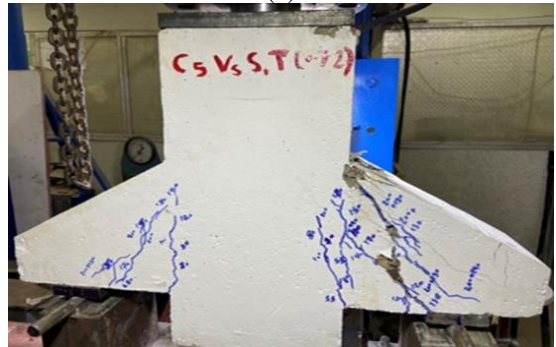
Figure 14. (a) Load-deflection of specimen C5 and C1; (b) Failure mode of specimen C5 [9]

The corbel features a vertical square tangential opening, centrally located along the Z-axis, with dimensions of 35 mm by 35 mm. The curve of load deflection for this corbel is shown in Figure 14(a). It shows that the highest load applied was 130 kN at the column face. The initial crack in the form appeared at a load of 27.5 kN, which is about 21.2% of the maximum load. This initial type of break, classified as a

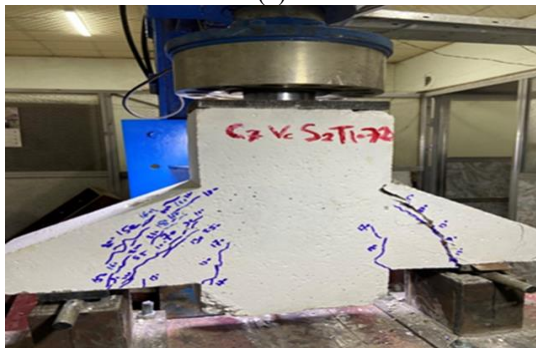
Figure 15. (a) Load-deflection of specimen C₇ and C₁; (b) Failure mode of specimen C₇

The corbel in this specimen features a vertical circular opening with a diameter of 40 mm, positioned 75 mm from the column and at the midpoint of the corbel's breadth. As illustrated in Figure 15(a) The final load is 140 kN. The initial significant fracture in the corbel manifested parallel to the aperture at a load of 27.5 kN (about 19.6% of the maximum load). This was the initial type of fracture (flexural fracture), with a maximum dimension of 1.5 mm, representing an increase of roughly 50% compared to the main corbel C₁. The failure transpired at the support's periphery as the crack traversed from the upper to the lower section of the opening close to strut of compression next to the hole, culminating in load failure at 140 kN, as illustrated in Figure 15(b). The type failure resulting from the pattern of cracks was diagonal splitting and shear failure, ductile failure, with the failure method of opening classified as beam type. A reduction in the ultimate load capacity might be attained at around 6%. Furthermore, there is no addition in deflection under load service and the cracking stiffness is inferior compared to control specimen C₁, as shown in Figure 15(b) (i.e., the number of cracks exceeds that of the control specimen, and the stiffness of the specimen is lower than that of control specimen C₁).

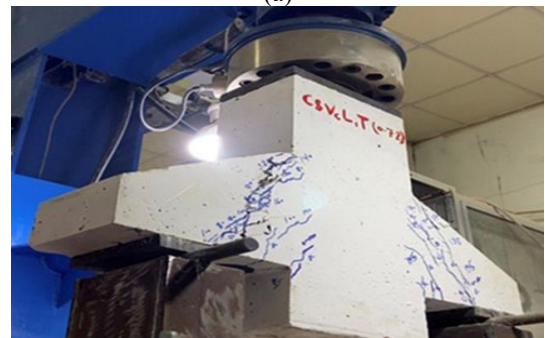
Figure 16. (a) Load-deflection of specimen C₈ and C₁; (b) Failure mode of specimen C₈

The corbel in this specimen features a vertical circular opening with a diameter of 40 mm, positioned 75 mm from the column and at the midpoint of the corbel's breadth. As illustrated in Figure 16(a). The maximum load was 140 kN. The initial significant fracture in the form emerged parallel to the aperture at a load of 27.5 kN, which is roughly 19.6% of the maximum load. This was the initial type of fracture (flexural fracture), with a maximum dimension of 1.5 mm, representing an increase of about 50% compared to the main corbel C₁. The failure transpired at the support's periphery as the crack traversed from the upper to the lower section of the aperture near the compression strut adjacent to the aperture, culminating in failure at a load of 140 kN, as illustrated in Figure 16(a). The fracture pattern resulted in a failure type known as diagonal splitting and shear failure, also known as ductile failure. The failure method of the opening was classified as beam type. A reduction in the ultimate load capacity might be attained at around 6%. Figure 16(b) shows that the cracking stiffness is lower than that of control specimen C₁, and there is no increase in deflection under service load. This means that there are more cracks than in control specimen C₁, and the stiffness of the specimen is lower than that of control specimen C₁.

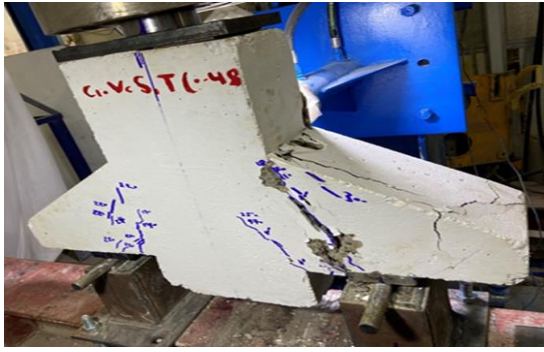
Figure 17. (a) Load-deflection of specimen C_{10} and C_1 ; (b) Failure mode of specimen C_{10} and C_1

The corbel in this specimen features a vertical circular opening with a diameter of 40 mm, positioned 75 mm from the column and at the midpoint of the corbel's breadth. As illustrated in Figure 15(a), The ultimate applied load is 140 kN. The initial significant fracture in the corbel emerged parallel to the aperture at a load of 27.5 kN (about 19.6% of the ultimate load). This first type of crack is a flexural crack, with a maximum width of 1.5 mm, representing an increase of roughly 50% compared to the main corbel C_1 . The failure transpired at the support's periphery as the crack traversed from the upper to the lower section of the opening beside the hole on the compression strut, culminating in failure at a load of 140 kN, as illustrated in Figure 17(a). The crack pattern resulted in diagonal splitting and shear failure, also known as ductile failure, and the failure method of the opening was classified as beam type. The final load capacity could be reduced by approximately 6%. Figure 17(b) shows that the cracking stiffness is lower than that of control specimen C_1 , and there is no increase in deflection under service load. This means that there are more cracks than in control specimen C_1 , and the stiffness of the specimen is lower than that of control specimen C_1 .

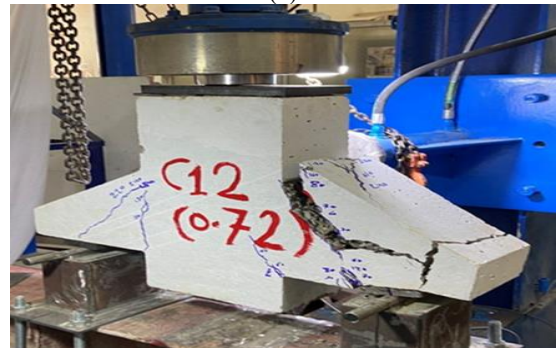
Figure 18. (a) Load-deflection of specimen C_{12} and C_1 ; (b) Failure mode of specimen C_{12} [9]

This specimen lacks horizontal links and openings, serving as a reference for the subsequent model. At a maximum force of 125 kN, Figure 18(a) shows that the initial diagonal fracture in the corbel showed up at the column face when the load reached 30 kN, which is about 24% of the maximum load. It was a diagonal shear crack with a maximum fracture width of 1.25 mm. The corbel's failure was triggered by the advancement of a crack via the compression strut from a point load at a weight of 125 kN. Figure 18(b) illustrates that the fracture pattern causes shear failure, which is a brittle failure.
