Non-Destructive Assessment of Internal Wood Conditions Using a Developed Electrical Capacitance Tomography–Dielectric Spectroscopy System

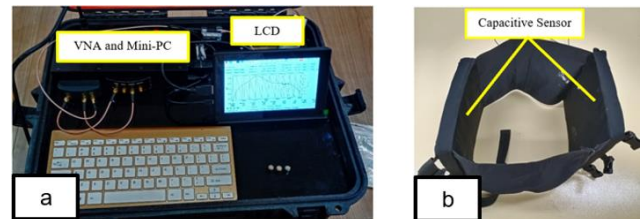
Figure 1. Prototype of ECT-S system (a) DAS component and (b) Belt-shaped capacitive sensor

The electrical properties of wood were assessed non-destructively using a capacitance-based measurement system, as described by Oktapiani et al. [26] and Agustiningrum et al. [27]. This system generates static electrical signals across a wide frequency range, from 250 kHz to 60 MHz. A Data Acquisition System (DAS), a Vector Network Analyzer (VNA), and a mini-PC were integrated with a capacitive sensor to conduct the measurements. The sensor consists of parallel copper plates and incorporates a noise suppression mechanism to enhance signal accuracy. As illustrated in Figure 1, the sensor is designed as a flexible belt, allowing it to conform to the curvature of the wood logs for optimal

The flexible capacitive sensor platform, featuring parallel copper electrodes, performed reliably across a range of wood diameters. Its belt-shaped design allowed conformal attachment to wood surfaces, while internal damping mechanisms helped reduce signal noise. The system produced consistent signal responses within the frequency range of 250 kHz to 60 MHz, with distinct resonance behavior typically observed between 17 and 30 MHz.

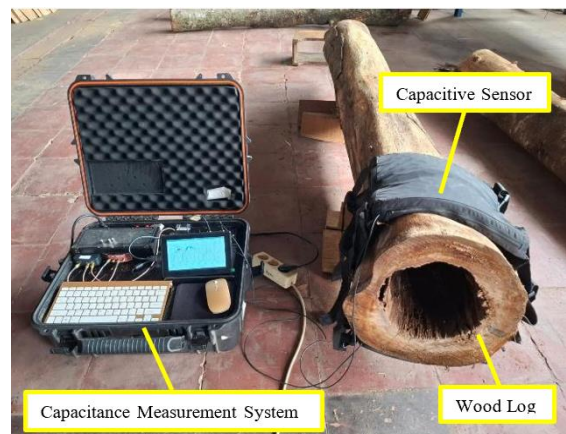
Figure 3. Experimental setup for measuring wood electrical characteristics in a wood log

Figure 3 presents the full equipment setup, including the sensor installation on the logs. Electrical measurements were conducted along the full length of each log by dividing it into 30 cm segments, corresponding to the width of the sensor.

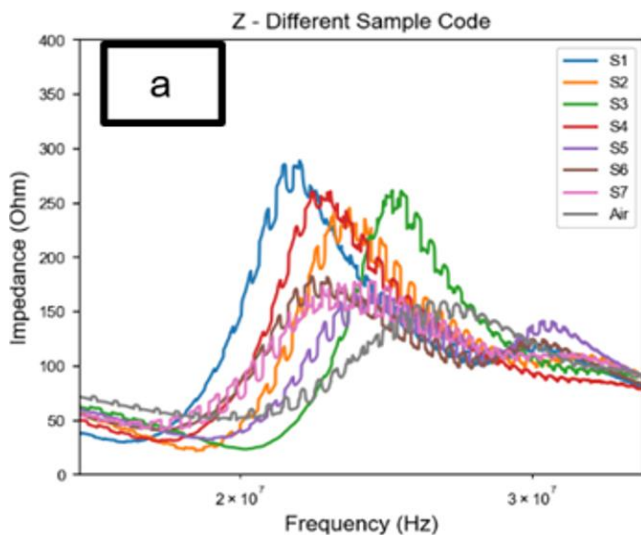
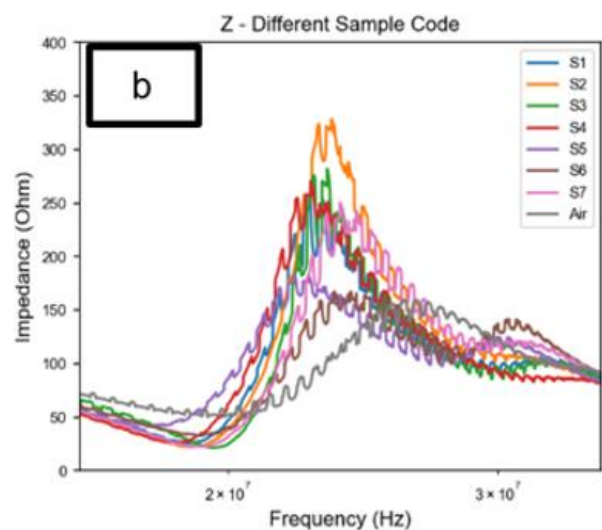
Figure 6. Impedance graphic of each log and segment compared with air as reference (a) Log 1, (b) Log 2, (c) Log 3, (d) Log 4, (e) Log 5, and (f) Log 6

Figure 6 presents the impedance magnitude spectra for each individual log segment, highlighting the frequency-dependent electrical behavior across varying internal conditions. The intact logs (e.g., Log 4, Log 6) consistently show high and stable impedance in the 17–30 MHz range, with gradual slopes and minimal fluctuations. These smooth profiles are characteristic of dielectric continuity, reflecting structurally sound wood with evenly distributed moisture and intact cellular architecture. The impedance peaks correspond to high capacitive opposition to current flow, as expected in solid and homogenous dielectric media.

In contrast, hollow logs (e.g., Log 1, Log 3) display significantly lower impedance magnitudes across the entire spectrum. This reduction is especially evident in the high-frequency region (above 25 MHz), where impedance curves flatten and show a complete absence of resonance features. This behavior indicates the dominance of air-filled voids, which reduce the effective relative permittivity and disrupt internal capacitive networks. The lack of clear spectral transitions suggests limited field interaction with solid wood material, in line with severe structural loss.

Decay-affected logs (e.g., Log 2, Log 5) demonstrate intermediate impedance behavior, with irregular curve shapes and localized dips in the 20–30 MHz band. These features may represent partial resonance effects resulting from decayed tissues acting as lossy, inhomogeneous dielectrics. The presence of fluctuating impedance gradients implies heterogeneous moisture content and breakdown of wall-bound water retention in partially degraded wood regions. In several cases, a mild resonance signature appears near 23–27 MHz, possibly caused by cavity-like geometries formed during mid-stage degradation.

Taken together, the spectral profiles in Figure 6 provide a diagnostic basis for distinguishing between wood conditions through their dielectric signatures. The resonance behavior observed in decayed samples, the damping of impedance in hollow logs, and the preserved permittivity in intact wood support the feasibility of frequency-based feature extraction.
