RURAL ARCHITECTURAL HERITAGE CONSERVATION AND SUSTAINABILITY IN TURKEY: THE CASE OF KARACA VILLAGE OF MALATYA REGION

TUBA NUR OLĞUN & MÜJGAN BAHTIYAR KARATOSUN

Architecture Faculty, Firat University, Turkey & Architecture Faculty, Dokuz Eylül University, Turkey.

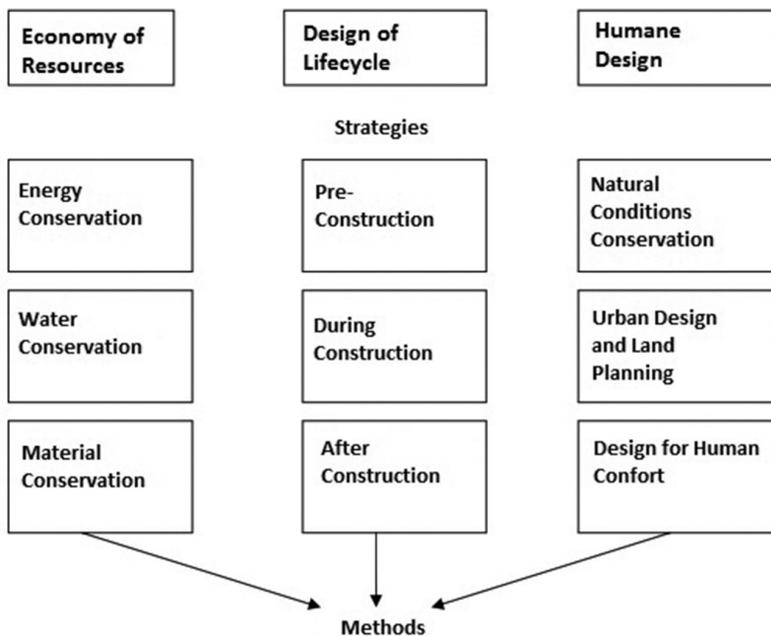
Figure 1: Framework for sustainable design [2, 4].

When the relationship between sustainability and architecture is examined, it is seen that the studies in this area have started to develop in the near future. Sustainability has been adopted as a guide for many disciplines [2]. Sustainability, whose sources are balance, responsibility, planning, participation, scientific efficiency, communication, integration and equality, are closely related to architecture [3]. Therefore, the framework of sustainable design in architecture can be expressed as in Fig. 1.

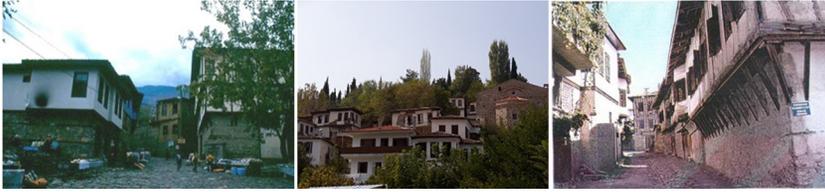
Figure 2: Traditional Cumalıkızık, Şirince and Yörük villages in Turkey [7, 8].

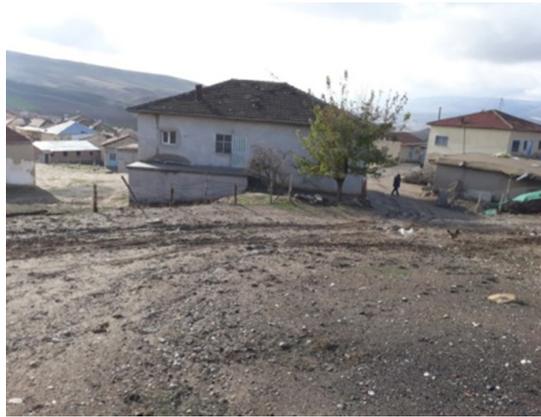
Figure 5: A view from Karaca Village.

One of the village settlements in Malatya, which stands out with its local characteristics in terms of its architectural characteristics, is the Karaca village (Figs. 4 and 5). Karaca village, which is a settlement of Yazihan district, has the following general characteristics:

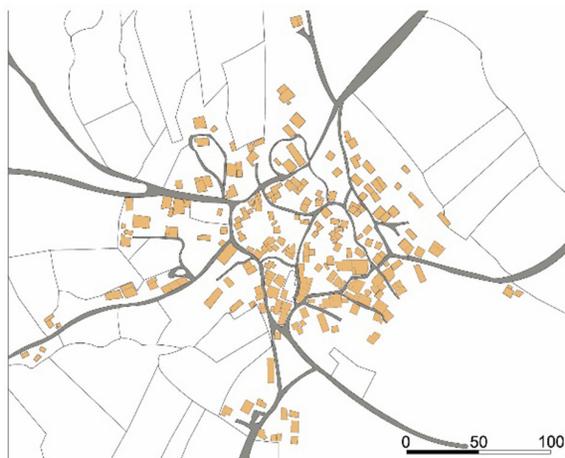
Figure 6: Site plan of Karaca Village.

Planning and architectural data: Maps and architectural resources related to the village could not be reached. For this reason, the site plan of the settlement has been formed with the help of the studies carried out in the field (Fig. 6). There are approximately 140 buildings with different functions within the boundaries of the settlement area. It was found that 122 of these buildings were built with mudbrick materials and traditional construction techniques.

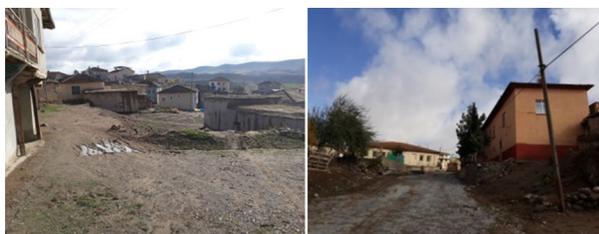
Figure 7: An earthen and a cobblestone ways.

- The settlement is composed of living areas in focus and agricultural areas surrounding these areas. In addition, not used for agricultural purposes; unregulated areas also surround the living areas of the village settlement.
- It is seen that the street pattern is shaped in an organic way.
- Most of the roads in the settlement are unregulated soil roads. Some roads are arranged with cobblestone (Fig. 7).
- Some houses within the settlement are designed to be adjacent to animal shelters. In some houses, animal shelters are arranged on the ground floor of living spaces (Fig. 8).
- Some of the houses are in the garden; most of them take direct entry from the street (Fig. 9).

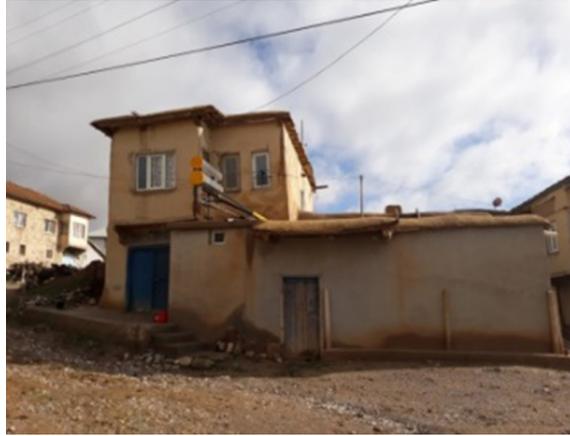
Figure 8: A house with an animal shelter.

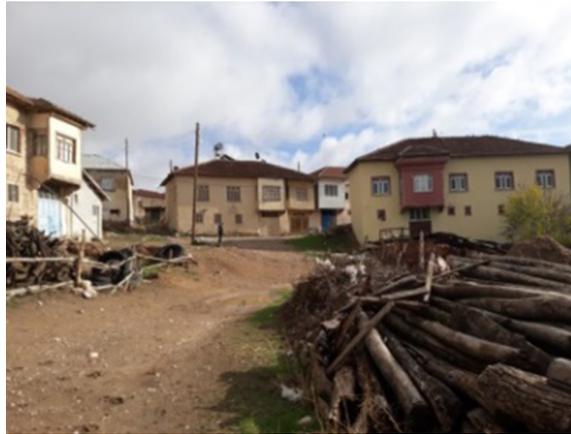
Figure 9: Buildings entered from the street.

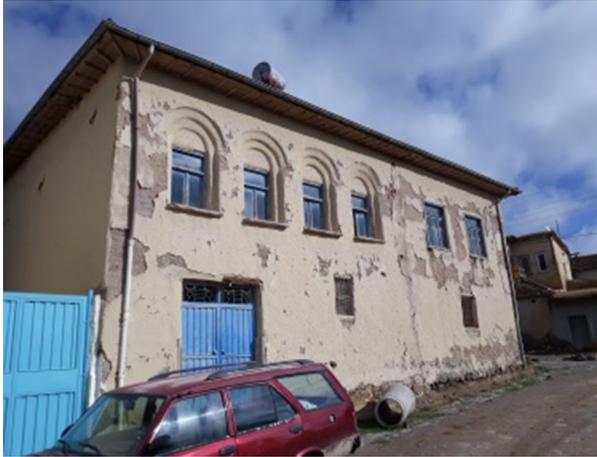
Figure 10: An example of window with 'kantamar'.

- Structures are usually composed of one or two floors. Some of the two-storey buildings have exits on the entrance facades. However, in some buildings, the outer surfaces of the windows are arranged as windows that are specific to the region, called the ‘window with kantamar’ (Fig. 10).
- Some of the buildings constructed with mudbrick material were plastered with concrete material in order to increase the life of the building.

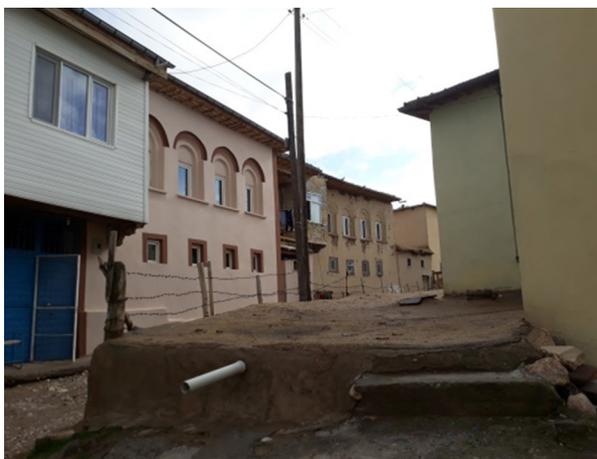
Figure 11: An example of window with 'kantamar'.

- There is no documentation about the original texture of the area and the structures that make up this texture. This paves the way for the destruction of many original structures before they can be documented.
- Reinforced concrete parts added to houses negatively affect the original characteristics of these buildings.
- In order to protect the buildings from harmful external influences, their facades are plastered with concrete. Therefore, the original facade characteristics of many buildings disappear.
- Some of the original structures in the settlement were built as reinforced concrete. This situation undermines the general characteristics of the settlement (Fig. 11).
