Effect of Soil Strength Degradation on Slope Stability

bank slope, strength degradation, long-term saturation, slope stability

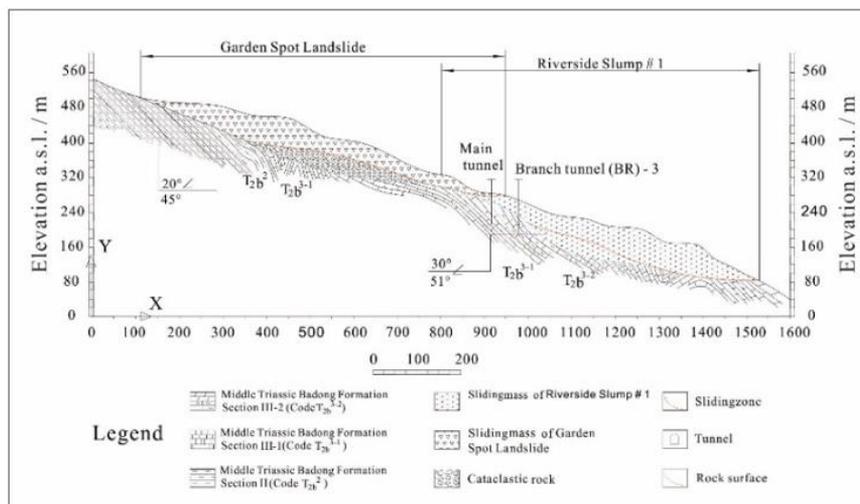
Figure 2. Engineering geological profile of the landslide

Samples used for the experimental study were taken from the slip zone of a typical reservoir landslide, named Huangtupo landslide in the TGR region, approximately 69 km far away from the dam, seen in Figure 1. The Engineering geological profile of the landslide was depicted in Figure 2. This huge ancient landslide is consisted by four subordinate landslides (the Riverside Slump #1, the Riverside Slump #2, the Garden Spot Landslide, the Substation Landslide), and has been reactivated by the fluctuation of the reservoir water level. The in-situ deformation monitoring data show that the Huangtupo landslide is in the creeping deformation stage at present [11]. Soil samples were taken from the BR-3 tunnel in the Riverside Slump #1 (Figure 3), which is 770 m in length, 450 ~ 500 m in width and 69.4 m in thickness. The physical properties of the slip zone soil are illustrated in Table 1, the mean natural water content is 9.8%, the dry density is 2.07 g/cm³, the argillaceous particle content is 64.7%, and the mean plasticity index I_p is 11.7. Samples are silty clay with gravels, particle diameter varies from 60 mm to 0.005 mm, the nonuniform coefficient C_u is 300 and the curvature coefficient C_c is 0.03, as indicated by Figure 4. Results of the X-ray diffraction tests shown that the slip zone soil is consist of calcite, chlorite, illite, quartz, and feldspar in descending order

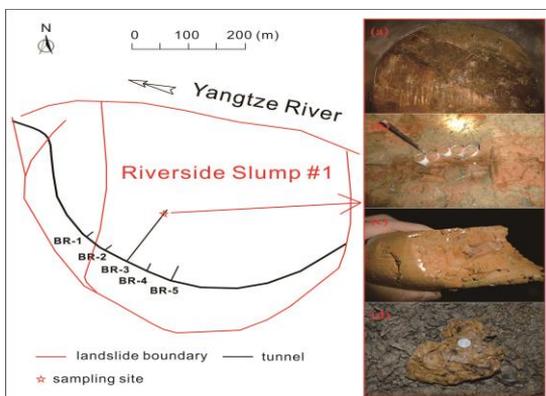
Figure 3. Site of in-situ sampling, including (a) sampling area; (b) in-situ sampling; (c) internal texture; (d) fragment of slip zone material

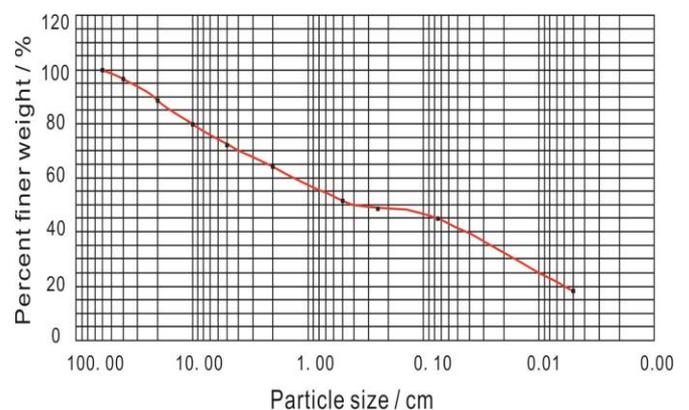
Figure 4. Particle size distribution of the slip zone soil

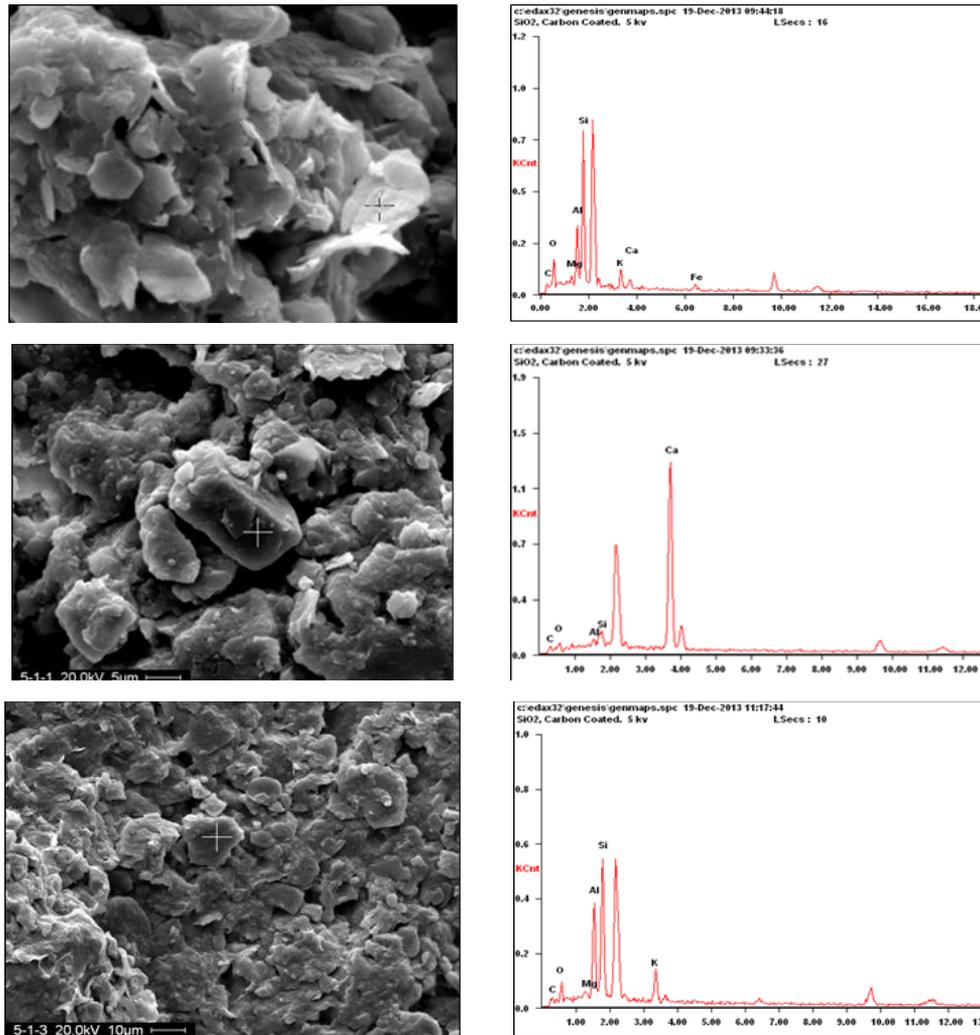
Figure 5. SEM images and energy spectrum of the slip zone soil

of abundance, and the expansibility is not obvious since the amounts of hydrophilic minerals is rare in the slip zone soil. Moreover, the layered sheets of clay and cuboid calcite are widely spread, as shown by Figure 5.

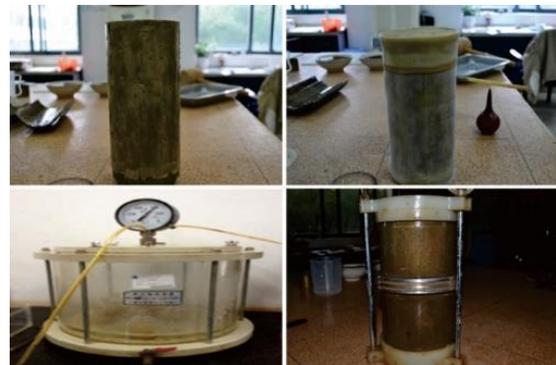
Figure 6. Preparation process of one cylindrical specimen used in the tests

Before the tests, samples of the slip zone soil were stoved, grinded down and sieved to get fine particles less than 2 mm. Afterwards, these fine particles were mixed with distilled water at natural water content for 24 hours, and then were compacted to cylinder specimens layer by layer, 39.1 mm in diameter and 80 mm in height ($\Phi 39.1 \times 80$ mm). The initial cohesive force and friction angle of specimens were detected as 57.8 kPa and 22.2°, through the consolidated undrain triaxial compression tests (CU). These specimens will be further used to study the strength degradation under the long-term saturation condition.

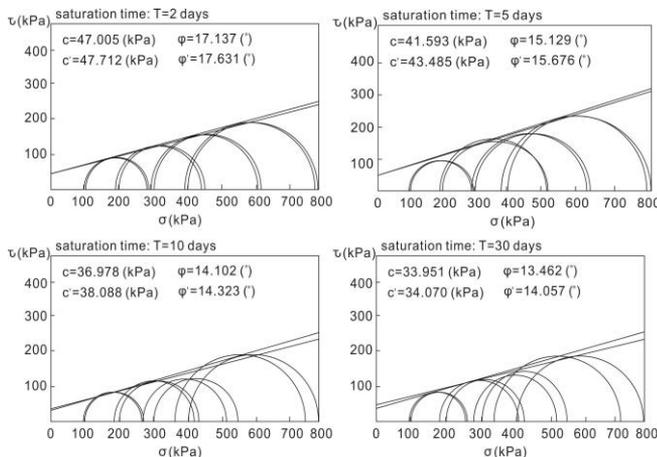
Figure 7. Strength value while saturation duration increases from 2 to 30 days

The specimen is characterized by clay soil as the gravels in the soil were removed, which means the internal water would be quite difficult to discharge when loaded. So, it is better to conduct the shearing test under the consolidated undrained condition, not only the testing time were shortened, but also the pore water pressure can be measured. On the basis of long-term saturation tests, the triaxial strength of slip zone soil was measured by CU tests after different saturation duration, results were shown in Figure 7. The pore water pressure of specimens was monitored during CU tests, so the variation of effective strength can be observed at the same time. Figure 7 shows that soil strength gradually decreases with saturation time increasing. When the saturation time varies from 2, 5, 10 to 30 days, the cohesive force of slip zone soil significantly decreased from 57.865 kPa to 47.005 kPa, 41.593 kPa, 36.987 kPa and 33.951 kPa, accordingly. While the friction angle reduced from 22.223° to 17.137°, 15.129°, 14.102° and 13.462°, respectively. The same attenuation regularity was found on the effective cohesive force and the effective friction angle of slip zone soil. It can be concluded that strength of slip zone soil reduced a lot at the first two days, as the cohesive force was 47.005 kPa and the friction angle was 17.137° when specimen was soaked in water for 2 days. With the saturation time going on, e.g. when it extended from 10 days to 30 days, the strength attenuation becomes weaken as the reduction of the cohesive force and the friction angle was merely 3 kPa and 0.6° in magnitude, respectively.

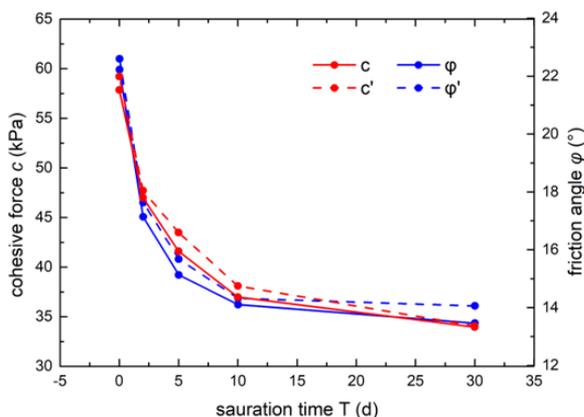
Figure 8. Strength variation in the long-term saturation tests

To reveal the strength variation characteristics, Figure 8 was plotted. Wherein, the red represents the cohesive force and the blue represents the friction angle, the normal strength and the effective strength were distinguished by solid and dash line. The cohesive force shows a negative relationship with saturation time, as well as the friction angle. Both the cohesive force and the friction angle degraded exponentially with saturation time going on. The reduction of cohesive force and friction angle was 18.8% and 22.9%, 28.1% and 31.9%, 36.1% and 36.5%, 41.3% and 39.4%, corresponding to 2, 5, 10, 30 days saturation. Similar degradation characteristics were found on the effective strength for both test results.

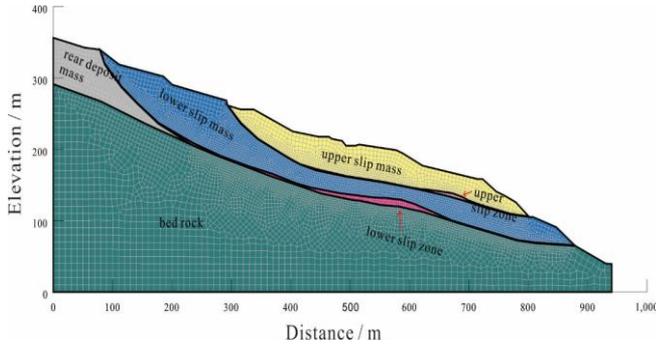
Figure 9. The numerical model of Huangtupo landslide used in simulation modelling

Based on the above test results, the strength deterioration of slip zone soil was taken into consideration in evaluating the time-varying stability in a relatively long period. The finite difference method was selected in modelling, which has been widely used in engineering [26]. A two two-dimensional model was built according to geological exploration data, and it was 940 m horizontally and 350 m vertically (seen in Figure 9). It was consisted of six parts: upper slip mass, upper slip zone, lower slip mass, lower slip zone, rear deposit mass and bed rock. The material composition of slip body, slip zone, bending rock are gravel soil, silty clay, muddy sandstone, respectively. The physical mechanic parameters of each zone used in numerical simulation was shown in Table 2.

The bottom of the model was fixed at both vertical and horizontal direction, while the left and right side of the model were fixed at horizontal direction.

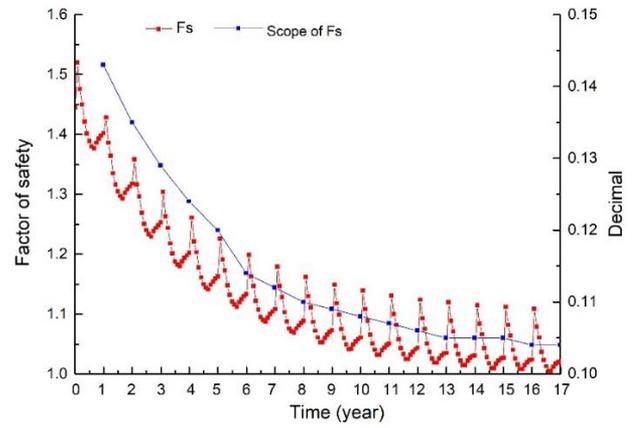
Figure 10. The time-varying stability of landslide in 17 years

When the strength deterioration formula was taken into account, the change of landslide stability was illustrated by Figure 10. Table 3 shows the stability coefficient in 17 years, the minimum F_s of investigated landslide reduces from 1.377 to 1.005 in 17 years, and the annually difference of F_s reduces gradually to a constant value in exponential format with time going on. So, it can be deduced that the influence of the strength attenuation on the value F_s becomes weak as time going on.
