THERMAL PERFORMANCE OF PLASTERED RICE STRAW BALES AND WALLS: A CASE STUDY

G. GARAS & M. ALLAM

Civil Engineering Department, National Research Centre, Egypt.

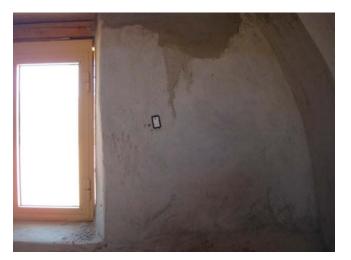
Figure 2: Sensor installed on the wall inside the building compartment.

Two thermal sensors are stuck on the internal and external walls of each of the four main directions of the straw bale compartment (Fig. 2). The readings were recorded continuously for 12 executive days in the hottest month of the year (July).

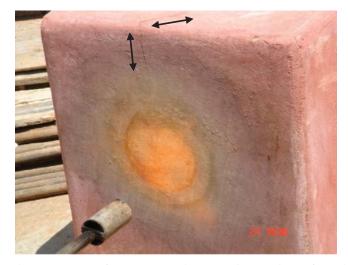
The specimen with the highest lime content, Mix C with cement:lime:sand in the ratio of 1:2:9, developed a visible crack at the specimen highest corner above the exposed area after 25 minutes (Fig. 3). The crack increased in size by the time and smoke was visible coming out of it (Fig. 4). Hair cracks appeared on the exposed side of the specimen after about 90 minutes of the continuous flame

Figure 3: The appearance of a narrow crack on Specimen Mix C after 25 minutes.

Cracks initially appeared at the weak corner of specimen C with highest lime content while by decreasing this component and increasing the amount of cement in the mix no cracks were noticed.
