SECURING THE SAFETY OF HERITAGE BUILDINGS IN ACTIVE SEISMIC REGIONS

ABSTRACT

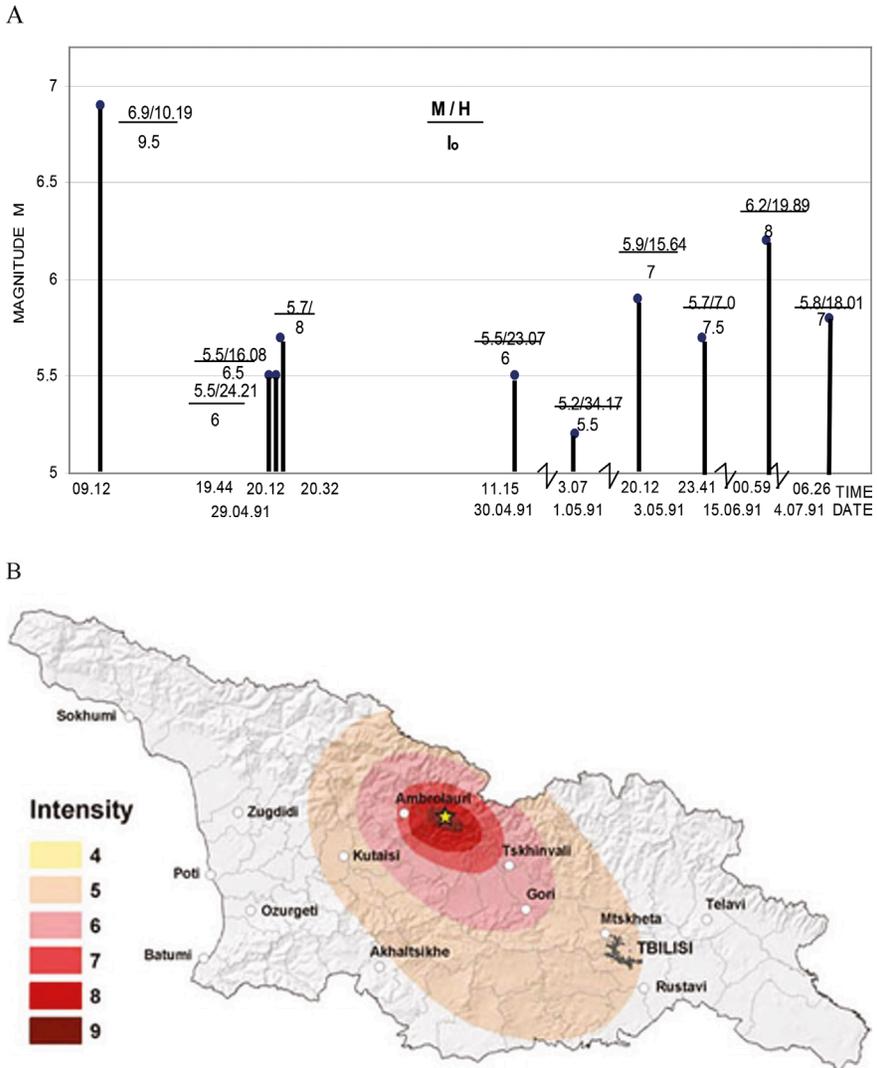
Figure 1: Seismic situation caused by the earthquake in Racha, Georgia, between April 29 and July 04, 1991, in the epicenter: (A) diagram: M – Richter magnitude; H – focus depth, km; I₀ – intensity on MSK-64 scale. (B) calculated earthquake intensity map.

On April 29, 1991, there was an earthquake in northern Georgia. Magnitude of the earthquake in Racha, Georgia, on April 29, 1991, by Richter scale according to the accepted estimations was $M_s = 6.9$ [26]. This magnitude corresponds to the intensity of $I_0 = 9.5$ on the MSK-64 12-step scale. Over 46 thousand buildings were damaged or destroyed. Several thousands of aftershocks were registered later on, during four months. Their magnitudes varied between $M = 6.2$ and 5.3 , being sometimes almost as powerful as the primary shock. The following chart (Fig. 1) illustrates this situation [6].

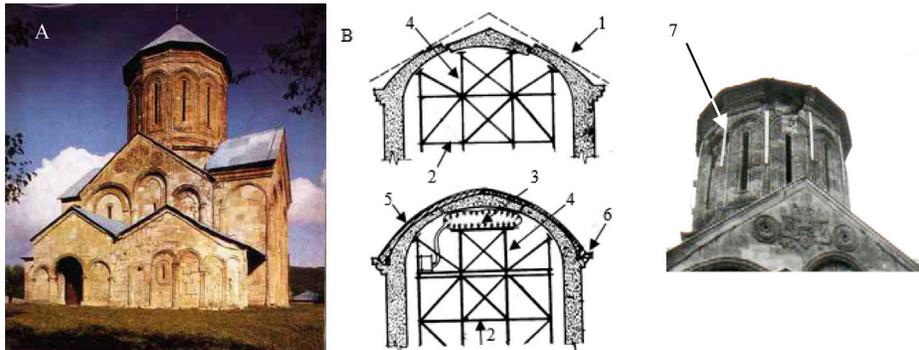
Figure 2: The temple in Nikortsinda. (A) General view; (B) damage of the dome and repair works: (1) dome; (2) scaffolding; (3) air pillow; (4) pillow support; (5) reinforced shell; (6) ring beam; (7) vertical timber boards.

The Nikortsminda temple was built in the 11th century (approximately in 1014). It has a cross-shaped structure with a drum and a brick dome (Fig. 2). The overall height of the structure is approximately 26 m, the dome span is 6.4 m, and its rise is 2.8 m. The dome shell thickness is 0.6 ÷ 0.8 m. The drum has three-layer walls with overall thickness 1.0 ÷ 1.5 m, although weakened by windows. That shock caused cracking of the drum, and actually divided it into a group of vertically separated segments. In the dome, this generated a series

of radial cracks and a closed-loop horizontal crack at the shell top. The central disk of the shell thus moved downwards by $60 \div 100$ mm but was wedged by surrounding parts of the dome, and so did not collapse (Fig. 2B) [6].

Temporary conservation of the temple in Nikortsinda was carried out immediately after the main shock of the earthquake to prevent its collapse by possible aftershocks. The following measures were taken (Fig. 2A): external reinforcement of the dome ring beam, at the top of the drum (this included a ring bundle of diameter 10-mm steel wires); external reinforcing ‘hoops’, each consisting of several diameter 10-mm wires, mounted atop vertical timber boards (Fig. 2); internal scaffolding, designed to support damaged areas of the structure, including the drum and the dome. The temple performed at no further damage.

The permanent conservation project was completed 2 years later. Its major steps were as follows (Fig. 2B): construction of a steel belt around the ring beam of the dome; lifting of the central disk, weighing about 4 t, back to its original position (this was done using air pillows situated on the scaffolding, the gap between the disk and the surrounding shell, which remained after lifting, was filled with a lime-based mortar under pressure); filling of all radial cracks in the drum and in the dome by a lime-based mortar under pressure; construction of a reinforced concrete shell atop the dome (thickness: 80–90 mm, $f_{ck} = 30$ MPa). As a result of these works, the dome was turned into a two-layer composite structure. Its original shape was restored and strengthened by an external reinforced concrete shell. Therefore, the internal appearance of the dome did not change, which allowed further restoration of ancient paintings.

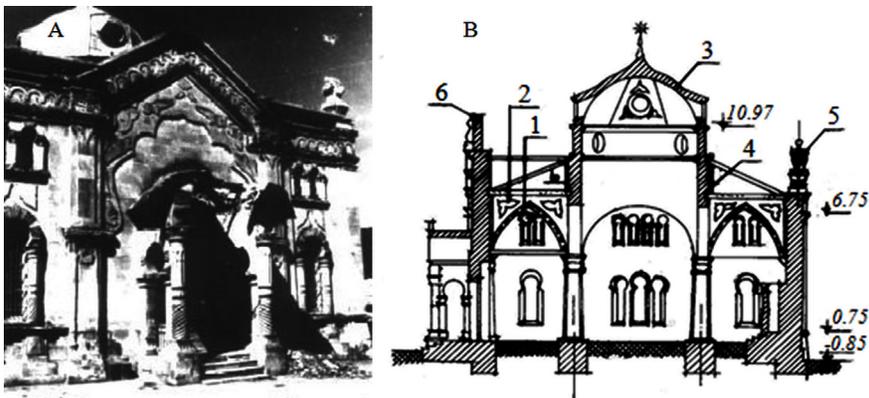
Figure 3: The synagogue in Oni: (A) view after the earthquake; (B) cross section: (1) arch; (2) ceiling; (3) dome; (4) drum; (5) collapsed sculpture; (6) collapsed facade element; (7) collapsed portico.

The earthquake caused substantial damage to the building, which did not collapse, however, due to its symmetrical structure, rigid walls, steel ties, and small arch spans. Overall views of the building after earthquake are presented in Fig. 3A. Cracks developed in actually all bearing elements, such as arches, shell, external walls, and in the drum (Figs 3 and 4). The crack opening in the arches was $5 \div 10$ mm. Many architectural elements and sculptures situated outside, at the facades, were severely damaged. Some of them collapsed, including fragments of walls (Fig. 3) [27].

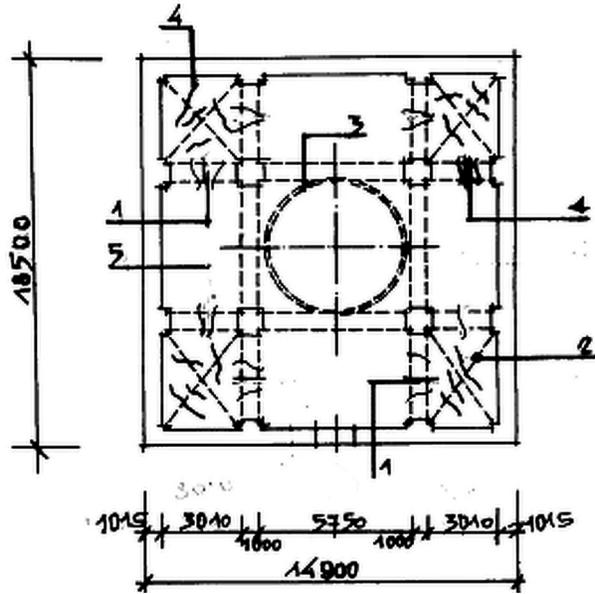
Figure 4: Plafond plan with the cracks shown (dimensions in mm): (1) arch; (2) surmounted vaults ceiling; (3) dome; (4) cracks; (5) wooden ceiling.

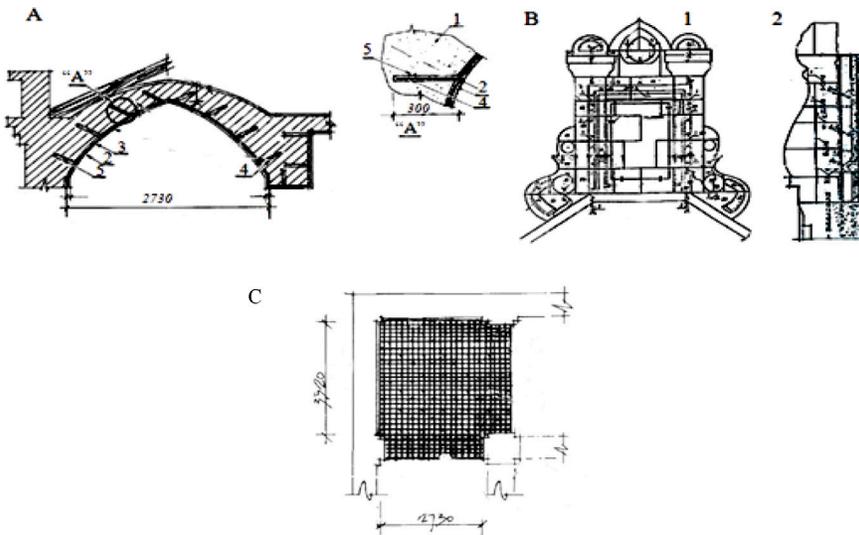
Figure 5: Details of strengthening (dimensions in mm): (A and C) details of arches and vaults reinforcement: (1) arch; (2) reinforced plastering layer; (3) steel mesh; (4) drilling; (5) steel anchor. (B) Strengthening of the frontal stele: (1) frontal façade and (2) lateral façade.

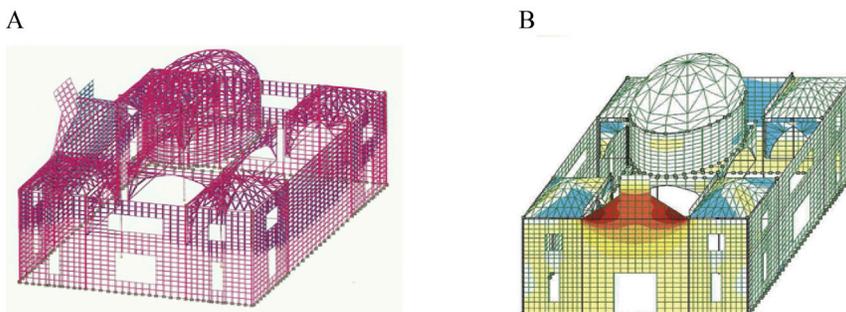
Figure 6: (A) Second mode shape in Y direction and (B) bending moments in Y direction.
*Y direction is perpendicular to the frontal façade.

Afterwards, to investigate the behavior of a building during an earthquake, a detailed analysis of seismic resistance was made using FEM [22]. Some results of structural analysis of the building under the action of seismic forces are presented in Fig. 6. When considering Fig. 5, we can see that the analyses given reflect the behavior of a building during an earthquake. In Fig. 6, we can clearly see how big are the displacements of the stele on the frontal wall. We can also see the concentration of the high-level stress at the base of the stele. Cracks in walls and corner vaults, destructions in the stele and shift of sculptures correspond to the results received. The results of such an analysis [28] given here correspond to the behavior of the building during the earthquake that makes it possible to recommend using FEM.

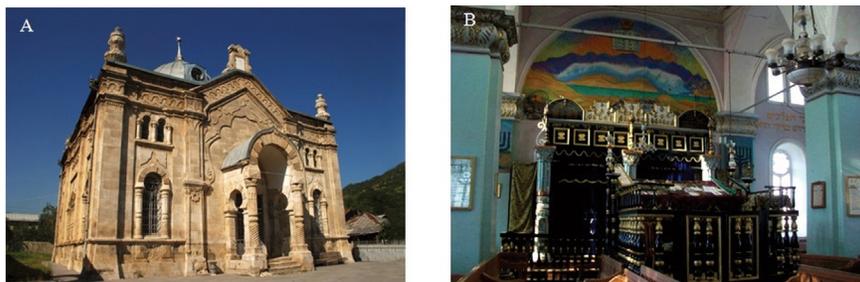
Figure 7: The synagogue in Oni after the strengthening and restoration: (A) general view and (B) interior.

The view of the synagogue in Oni after the strengthening and restoration is shown in Fig. 7.

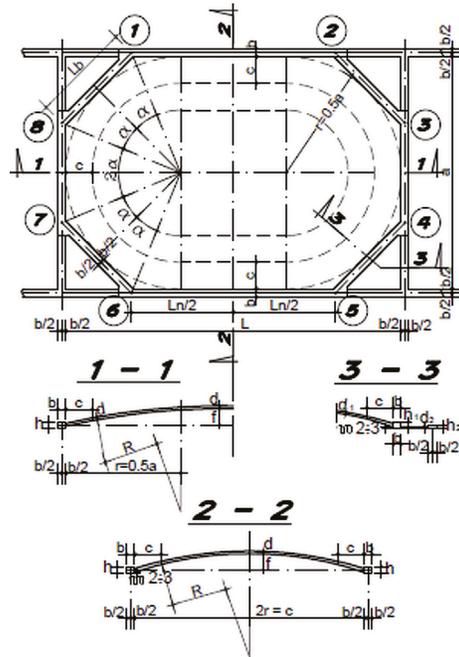
Figure 8: Ceiling shells with small rise.

In Khareli settlement (Republic of Georgia), there was the loss of stability and deformation of a monolith reinforced-concrete shell in a public building (Fig. 8). The shell sizes in plane are (net): 8.4 × 10.2 m, thickness: 8–10 cm, designed rise: 50 cm, designed strength of concrete: 11 MPa. The shell was built in 1960–1962. After 15-year operation, the stability was lost and the shell deformed due to the low grade of concrete under conditions of big slope (Fig. 9).

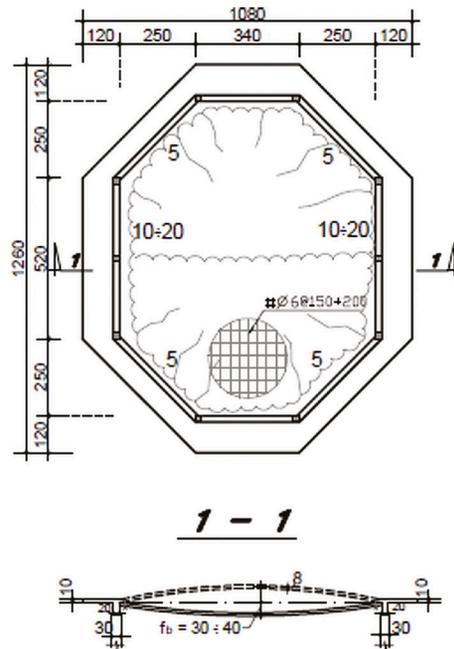
Figure 9: Rectangular shell after stability loss (dimensions in cm) together with scheme of cracks arrangement (width of cracks: mm).

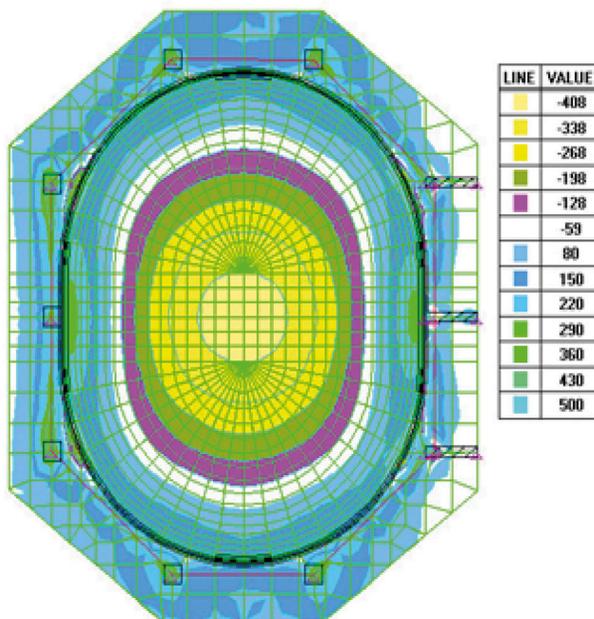
Figure 10: Normal stress in X direction (t/m²).

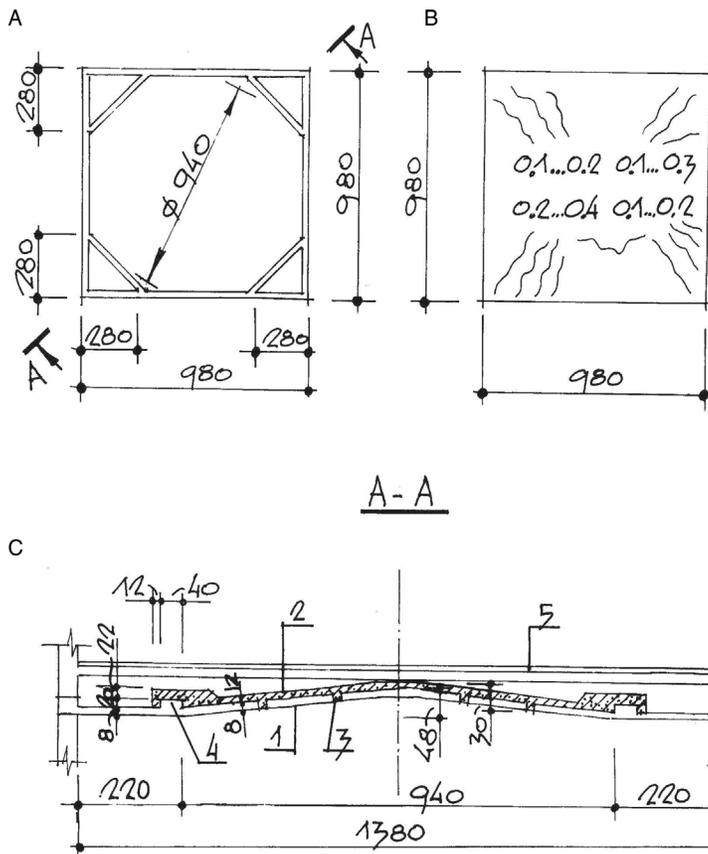
Figure 11: Very shallow reinforced concrete shell (dimensions in cm): (A) scheme of shell plane; (B) scheme of cracks arrangement on the lower surface of shell (width of cracks: mm); (C) scheme of strengthening shell: (1) old shell; (2) new shell; (3) reinforced concrete shell key; (4) contour beam; (5) construction of floor.

In one of the Civil buildings in Tbilisi (1952), there were floors constructed in a square plane with the dimensions of 10×10 m of very shallow reinforced concrete shells of the type being considered (Fig. 11A) [33]. The surface embedded in the octagonal shells of revolution is cone-like, rising within the rate of $f/a = (1/30-1/40)$. The actual concrete brand is 120–150 kg/cm^2 and the thickness of the shell is 6–8 cm. Continuous load-dead load of the shell and floor structure was equal to $560 \text{ kg}/\text{m}^2$, and the temporary load was $200-300 \text{ kg}/\text{m}^2$. After 20 years of operation, the surface of the shell at the edges developed local cavities and cracks. The scheme of cracking is given in Fig. 11B. It corresponds theoretically to the well-motivated single-parameter fracture scheme of shells of revolutions [23,24]. Due to great deformations, the temporary load was removed (a library and reading hall were placed over a shell) and the operation of shells was suspended. The designed carrying capacity of shells,

defined using actual geometry parameters reinforcement and concrete strength, was as follows [33]: according to the theory of limit equilibrium in relations [24] $q = 520 \text{ kg/m}^2$; according to the theory of limit equilibrium considering geometric nonlinearity [25], $q = 490 \text{ kg/m}^2$; according to the membrane theory of shells [34], $q = 400 \text{ kg/m}^2$ (proceeding from a condition of strength of the reinforcement supporting ring); according to stability (long-term strength) [34] – 160 kg/m^2 . Calculation displacement in the centre of shell is $w = 15.06 \text{ mm}$ ($w/h = 1.5/6 = 1/4$, $w/2R = 1.5/2 \times 470 = 1/625$, where R is the radius of a circle embedded in the octagon). These data show that the strength of the shell is not sufficient, and a great number of deformations are appropriate. As for the value determined proceeding from the stability condition, it then has considerable margin. This accounts for the fact that long coefficient of stability is in conformity with [33]. To restore operational qualities of the shells being considered, they were strengthened (Fig. 11C).
