## Stability analysis and evaluation of a landslide area in Sichuan

### ABSTRACT

Located on the northern bank of the Jinsha River, the Guanlinping landslide area of Longping Village, Xin'an Town in southwestern Pinshan County poses a great threat to the life and property of the local residents. In this paper, the stability of the landslide area is qualitatively and quantitatively analyzed through the examination of the engineering geological conditions and the influencing factors of stability.

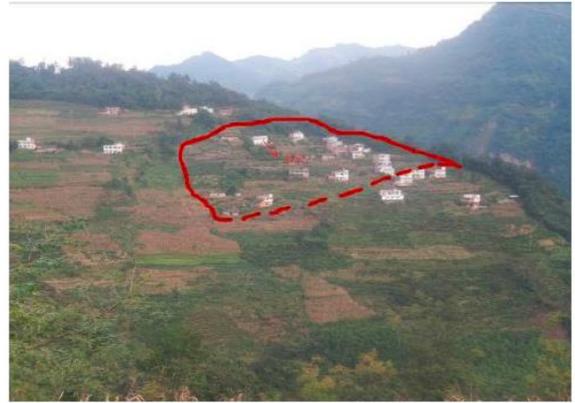
Figure 1. Panorama of the landslide

The landslide area covers around 60, 912m<sup>2</sup>. In the shape of a round-backed armchair, the area is about 216m long longitudinally and 282m wide laterally. The elevation of the low rear edge is 690m, and that of the tall front edge is 618m, putting the relative height difference at 72m. The average slope falls between 10~20. The strike and dip of the

underlying stratum of the area is  $275^{\circ}\angle 9^{\circ}$ . The topsoil is about 3~6m thick on average. With a total earth volume of  $24.36\times 106m^3$ , the research object is a medium-sized thrust load-induced shallow soil landslide area (Figure 1).

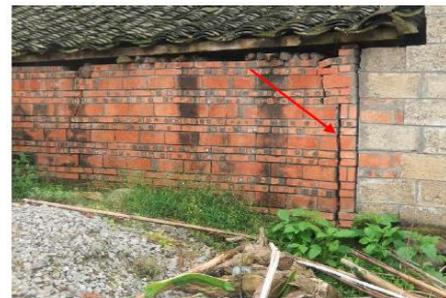
Figure 2. External wall cracking caused by rear edge tension cracks

The landslide area suffers from obvious deformations. Deformation failure is mainly demonstrated by ground cracking and subsidence, house tensile fracture, slope deformation and bulging deformation. The cracks in the landslide area concentrate in farmlands, buildings and courtyards (Figures 2~7). The rear edge of the landslide area is marked by a steep scarp near the southern ridge, where the bedrock is outcropped, the front edge is marked by the intersection of scattered scarps, the left edge is bounded by the lateral arc-shaped through cracks, and the right edge is bounded by the dividing line between steep and gentle landforms.

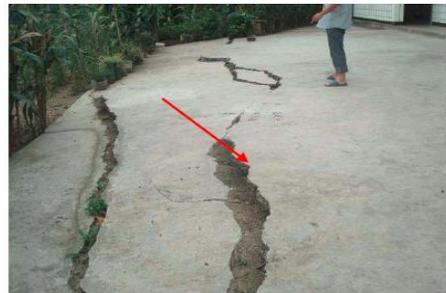
Figure 3. Courtyard settlement caused by rear edge tension cracks

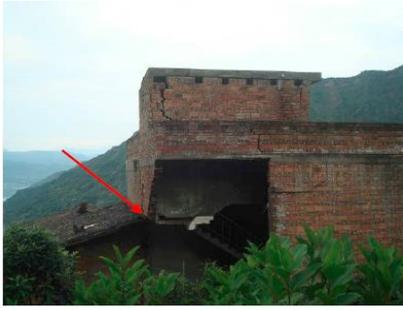
**Figure 4.** House damages caused by left edge shear cracks

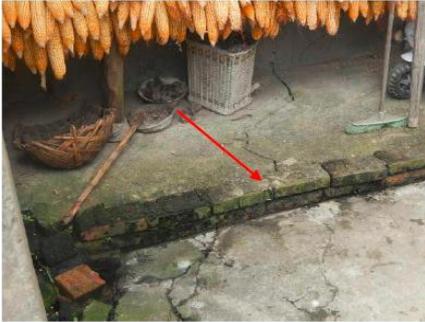
**Figure 5.** Courtyard cracking caused by left edge shear cracks

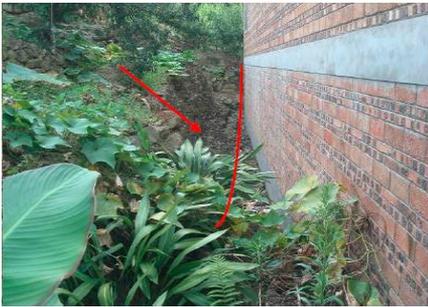
**Figure 6.** Retaining wall collapse caused by front edge bulging cracks
