DEVELOPMENT AND APPLICATION OF METHODS OF INTERNAL INSPECTION OF DISTRICT HEATING NETWORKS

I.I. MURTAZIN¹, M.V. KOZHEVNIKOV² & E.M. STARIKOV²

²Department of Energy and Industrial Management Systems, Ural Federal University, Russia.

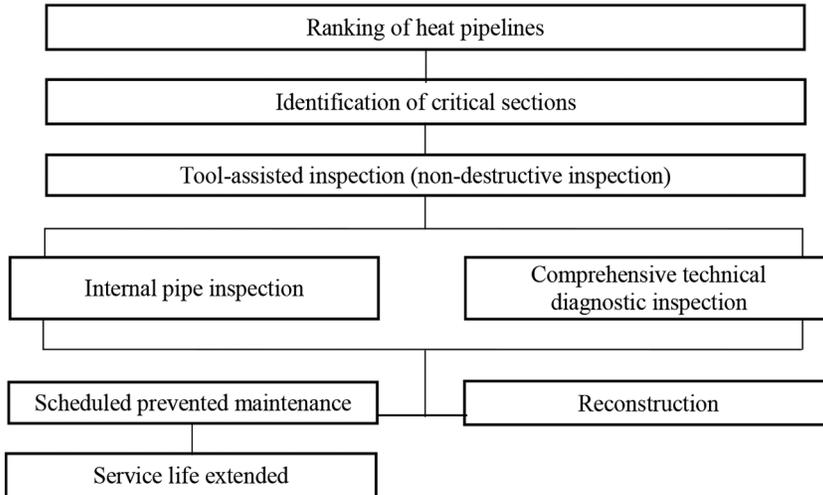
Figure 1: Algorithm for planning and carrying out repair works on the heating networks operated by the MOEK.

Phase III. A scheduled inspection and repair program for heat networks is formed (Fig. 1).

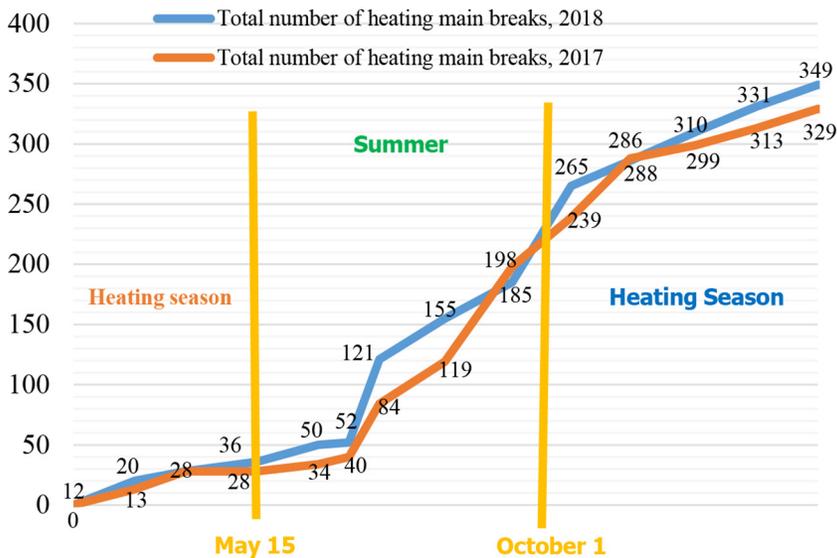
Figure 2: Timeline of heating main breaks in Ekaterinburg.

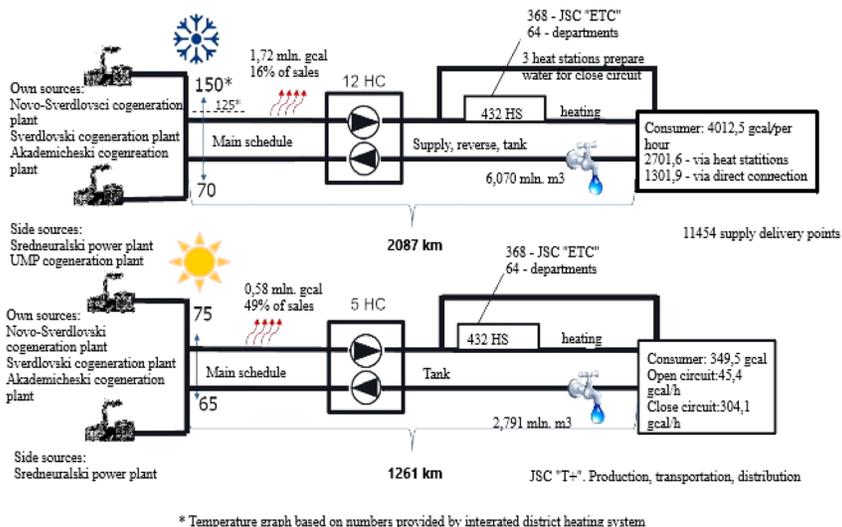
Figure 3: General information about EHGC -operated zone of united district heating network.

District heat assets in Yekaterinburg are maintained by the heat transport company Ekaterinburg Heat Grid Company (EHGC). It is one of the largest regional district heating companies in Russia by the size of network. EHGC supplies hot water and heat to 1.5 million domestic consumers. The company maintains 439 central heat distribution stations, 381.1 km of main heat pipelines, 2284.5 km of submain and distribution single-pipe pipelines (calculated as the total length of feed and return lines in the system), and 11 pumping stations. Figures 3 and 4 present an overview of EHGC’s heat supply zones.

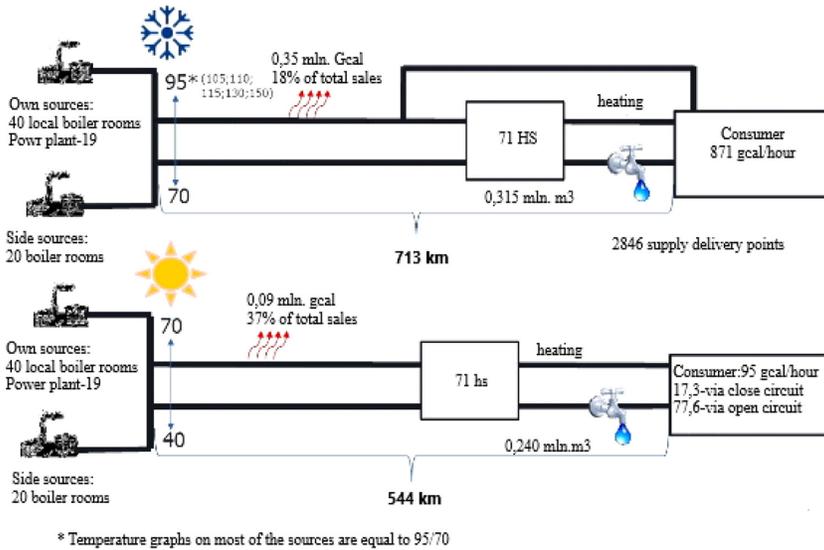
Figure 4: General information about EHGC-operated local sources zone.

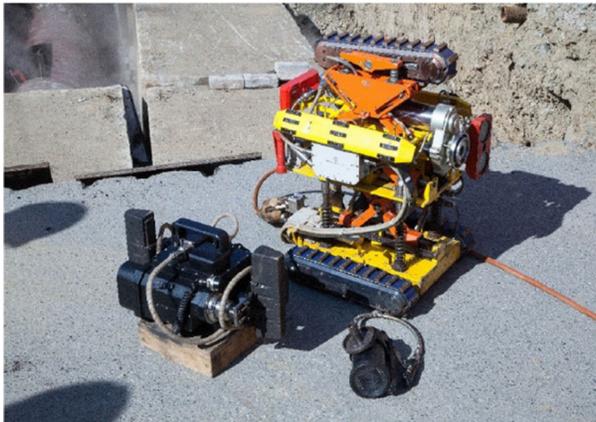
Figure 5: Remotely controlled inspection robot.

In 2018, the EHGC conducted NDT inspection of underground heat pipelines with a total length of 2374 km. The inspection was carried out using a remote-controlled pipe robot designed and manufactured by Diakont (Fig. 5). The robot was fitted with removable CCTV camera, KTC-4 (Fig. 6), and a magnetic control module, MMK-24 (Fig. 7).

The MMK-24 robot is designed for measuring the thickness of pipeline walls in areas of wall thinning with the diameter of no less than 300 mm and for detecting defects on the inner and outer surfaces of pipes along with simultaneous automated sweeping inspection applying **the AMF technique**. As explained in part 2 of the article, the latter is the most optimum method in the described circumstances.

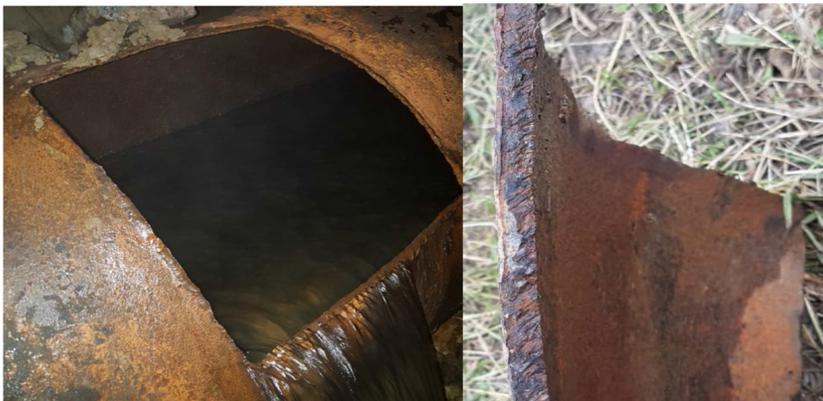
Figure 8: M-37 main pipeline damaged during hydraulic testing.

The pipeline was destroyed at 1.45 MPa: the pressure pushed out a 450 × 450-mm manhole cover. An examination of the destroyed area revealed that the damage was due to a badly welded joint of the temporary opening patch (Fig. 8). The destroyed area was outside the section that had been subjected to internal pipe inspection.

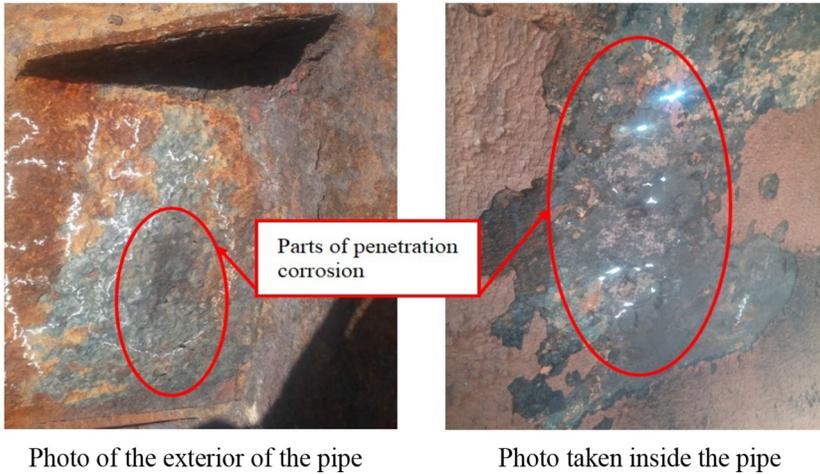
Figure 9: Penetration corrosion of defect No. 34, element 2.12–2.13.

For example, defect section No. 34 was found to have penetration corrosion (Fig. 9) that withstood pressure testing at 1.4 MPa, thanks to higher strength of the defect section in the

ribbing area of the fixed support as well as to a layer of corrosion deposits that had accumulated on the surface of the pipeline throughout its service life.
