APPROACHES FOR EVALUATING FAILURE PROBABILITY OF EMERGENCY POWER SUPPLY SYSTEMS IN HOSPITALS

CHI-HAO LIN, XIAOQIN LIU, CHENG-TAO YANG, YI-KUANG PAN & YU-CHIA LIAO
National Center for Research on Earthquake Engineering, Taiwan.

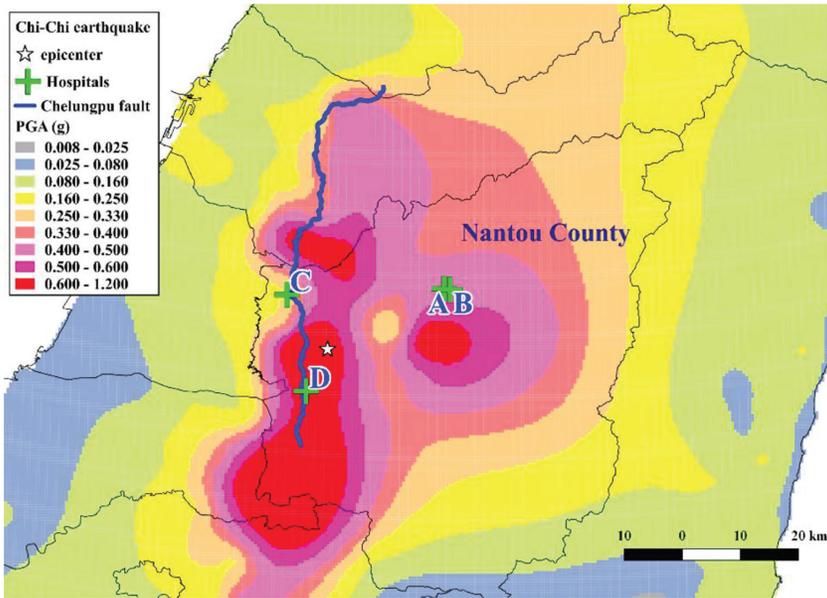
Figure 1: Seismic intensity map of the Chi-Chi earthquake and the location of the four hospitals.

Chuang *et al.* investigated the four first-aid hospitals (A–D) that were damaged in Nantou County [1]. Figure 1 shows a seismic intensity map of the Chi-Chi earthquake and the location of the four hospitals. The maximum PGA was approximately 1g. Table 6 shows the PGA at the four hospitals. The Chelungpu fault is a reverse fault. Hospital D was located on the

hanging wall and near the fault, only a short distance from the epicenter. Thus, it experienced a considerable ground motion. Although hospital C was also near the fault, it was located on the foot wall. Thus, the ground motion it experienced was not substantial. Hospitals A and B were adjacent and experienced the same ground-motion intensity.

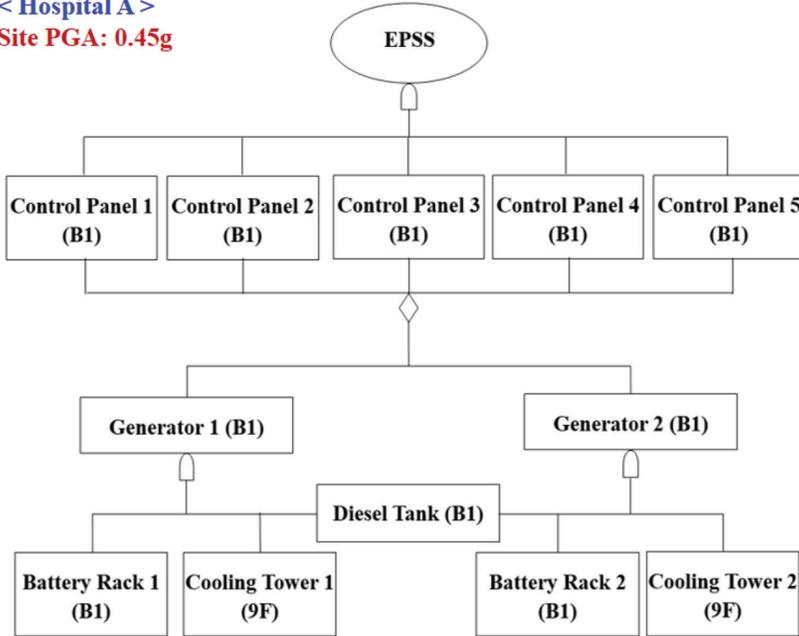
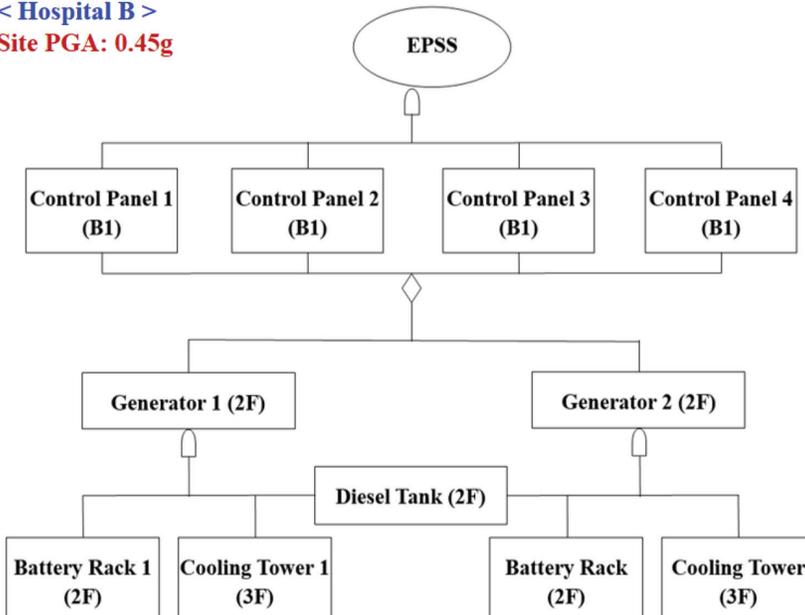
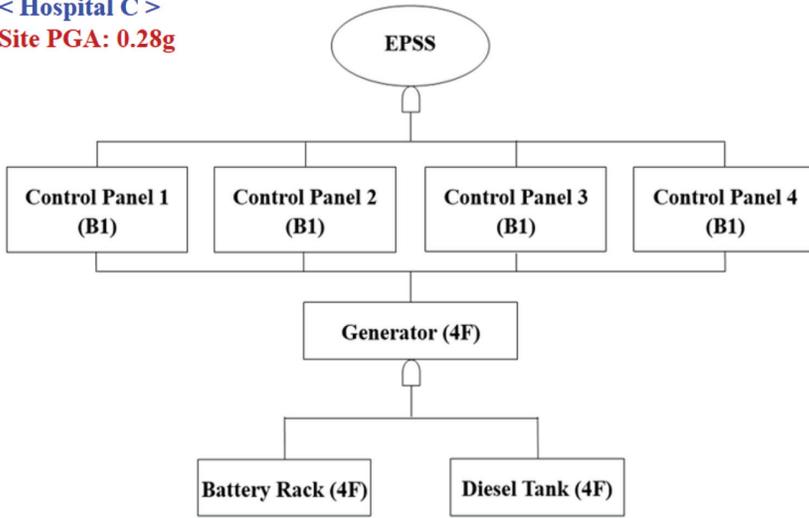
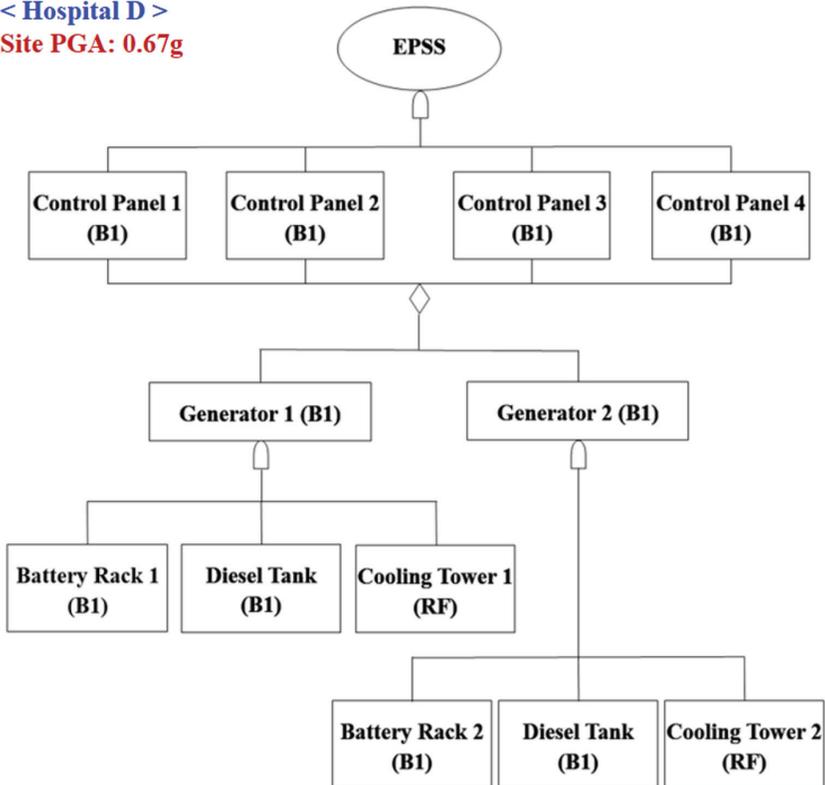
< Hospital A >
Site PGA: 0.45g

< Hospital B >
Site PGA: 0.45g

Figure 2: Logic tree diagrams of the EPSSs in Hospitals A – D.

< Hospital C >
Site PGA: 0.28g

< Hospital D >
Site PGA: 0.67g

Figure 2: (Continued)

Figure 2 shows a logic tree diagram of the EPSSs in the hospitals. Only the EPSS in hospital C had no cooling tower; the other hospitals had the five major components. The floor where the component was located is indicated in parentheses in the figure. B1 refers to the basement first floor. RF denotes the roof floor. The EPSSs in hospitals A and B differ in that

two generators used the same diesel tank. The failure path must be considered in the calculation of the probability. We took hospital A as the example case. The detailed process of our computation is shown in the following section.

The EPSS in hospital A had two generators that shared the same diesel tank. Therefore, the generator subsystems were not operated independently. Equations (2) and (3) cannot entirely solve this problem. The failure path must be considered for both subsystems. Furthermore, the peak floor acceleration (PFA) must include the acceleration amplification effect. In our study, the building floors were divided into three parts: the amplification factor of bottom part was set at 1.0, the top part was set at 2.0 and the middle part was set at 1.5.

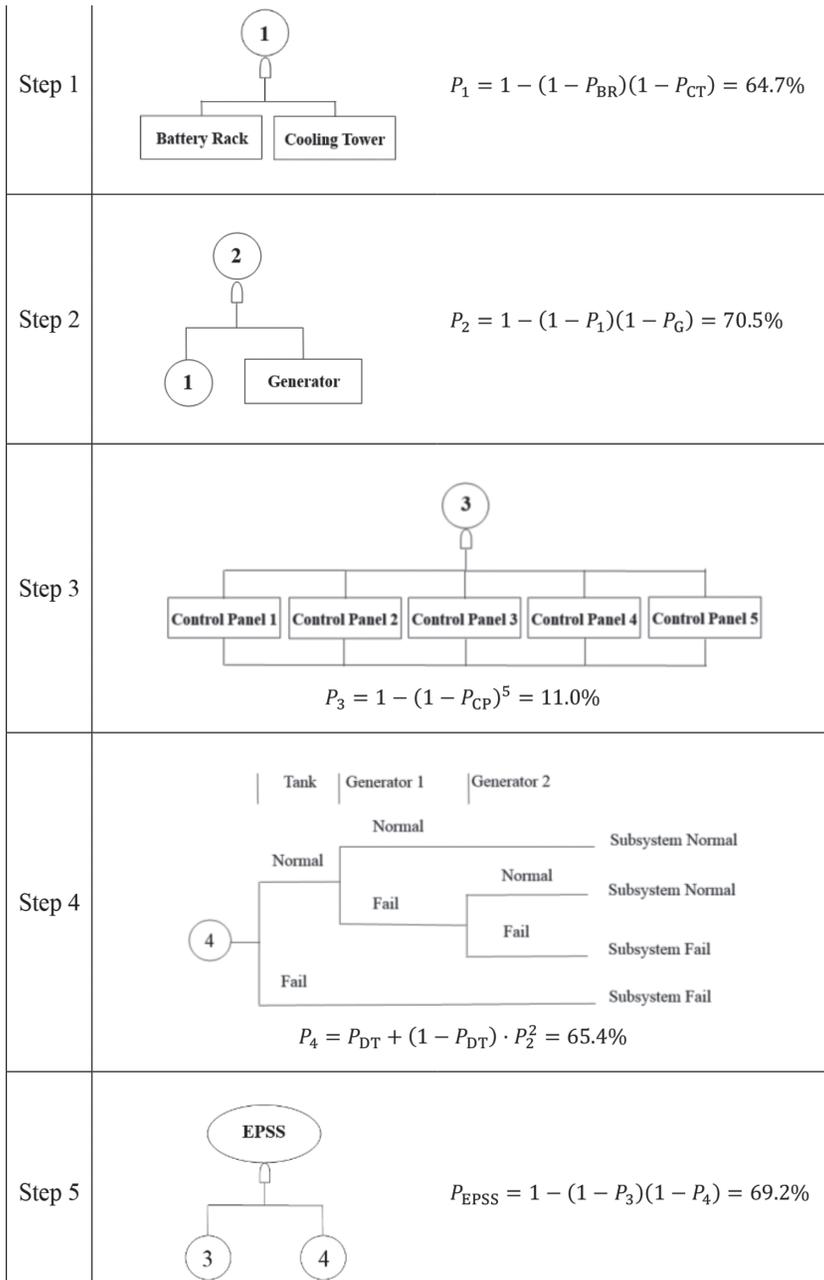
Figure 3: Derivation process of P_{EPSS} for hospital A.

Figure 3 shows the detailed derivation for the failure probability of the EPSS (P_{EPSS}). In general, we can obtain the failure probability of the upper event by using eqn (2) or eqn (3) according to the 'and' or 'or' gate. At Step 1, the battery rack and the cooling tower were taken as the lower events. The failure probability of Upper Event 1 (P_1) was calculated using eqn (2). At Step 2, the diesel bank was not included. The failure probability of a generator subsystem (P_2) was derived through an 'and' gate that was composed of P_1 and P_G . At Step 3, the failure probability of upper event 3 (P_3), which consisted of five control panels, was calculated. Because the two generators shared the same tank, we proposed the failure path shown in Step 4 for calculating the probability (P_4). Finally, we obtained P_{EPSS} by using P_3 and P_4 , which formed an 'and' gate.
