CRACK DETECTION OF IMMERSSED METALLIC STRUCTURE IN WATER WITH SURFACE OSCILLATION USING SCANNING LASER PULSE

J.Y. PARK¹, J.R. LEE¹, B.Y. KOO²

¹Department of Aerospace Engineering, Korea Advanced Institute of Science and Technology, Daejeon 305-338, Korea.

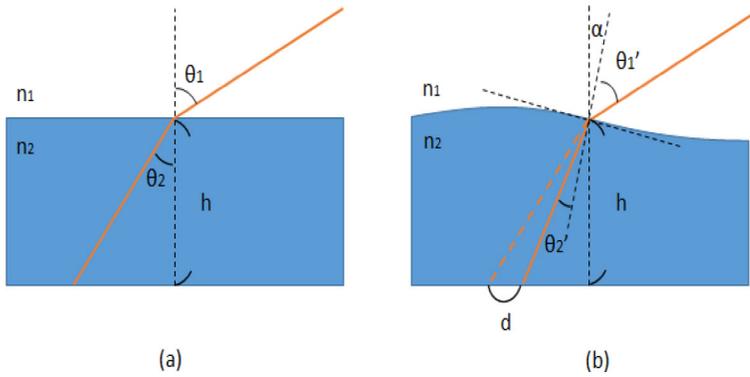
Figure 1: Snell's Law (a) still surface and (b) oscillating surface.

If the liquid surface is oscillated, the excitation laser pulse will be unstable so that it is impossible to reach to an exact grid point in the scanning area. This lead to the difficulty in the damage detection and the size measurement. For the oscillated water surface case, the difference between original grid point and changed point can be expressed as the eqn (1) below using subscription in Fig. 1.

However if we magnify the Fig. 1b, laser beam makes not just a point but some circular area as shown in Fig. 2a. Therefore, when the scanning process is repeated, the overlapped

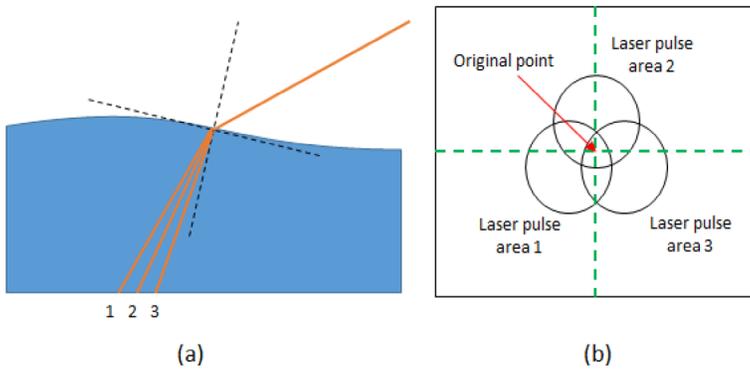
Figure 2: (a) Repeated laser pulse and (b) overlapped area.

area of the laser beam will close to the original grid when the oscillation is small enough. To verify this, ultrasonic propagation imaging system is utilized for three cases: free specimen, submerged specimen without surface oscillation and submerged specimen with surface oscillation.

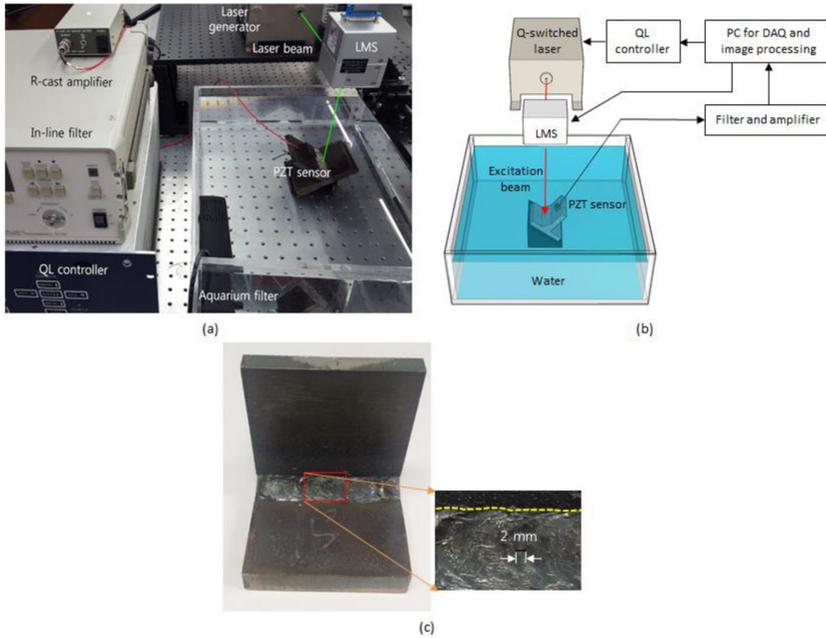
Figure 3: Experimental Setup (a) photo, (b) schematic of the ultrasonic propagation imaging system for submerged structural inspection and (c) T shape metallic specimen with a 2 mm crack on weld zone.

A photo and schematic of the ultrasonic propagation imaging system for submerged structural inspection used in the experiments are shown in Fig. 3a and b. The system consists of in-line signal conditioner with filters and amplifiers, a personal computer (PC) with data acquisition (DAQ) and signal processing algorithms and a 532 nm Q-switched continuous wave laser. The laser beam with energy of 1.2 mJ, generated by Q-switching technique, is directed to a laser mirror scanner (LMS) so that the laser beam can be reached to the specimen. The scanning area and the interval of laser pulse are 20 mm by 40 mm and 0.1 mm, respectively, and the pulse repetition frequency is set to 100 Hz. The ultrasonic wave is measured by a piezoelectric sensor with attachable magnetic sensor head and band-pass filtered between 350 kHz and 500 kHz then stored in the PC. The stored data is processed using algorithms which visualize the wave propagation and the damage, such as UWPI algorithm and AWS algorithm.

The specimen is T-shaped steel material which has the 2 mm by 0.3 mm crack is in the middle of the weld joint, as shown in Fig. 3c. Each the thickness of a bottom and a horizontal directional plate of the T-shaped specimen is 15 mm and 10 mm, respectively. In the experiments, the specimen is located in the middle of the water tank and fixed by an inclined bracket. As mentioned above, the tests are done in three cases: free specimen, submerged specimen without surface oscillation and submerged specimen with surface oscillation. Especially in a submerged specimen case with oscillated water, inspection is repeated 10 times to increase signal-to-noise ratio by repeating scanning technique. An aquarium filter (Hyubshin Water Design Co., LTD.) is located on the water tank corner to make random oscillation of water surface. The hole of an aquarium filter which makes the stream is located 40 mm above the bottom. Fig. 4 shows the random water surface oscillation caused by the stream.

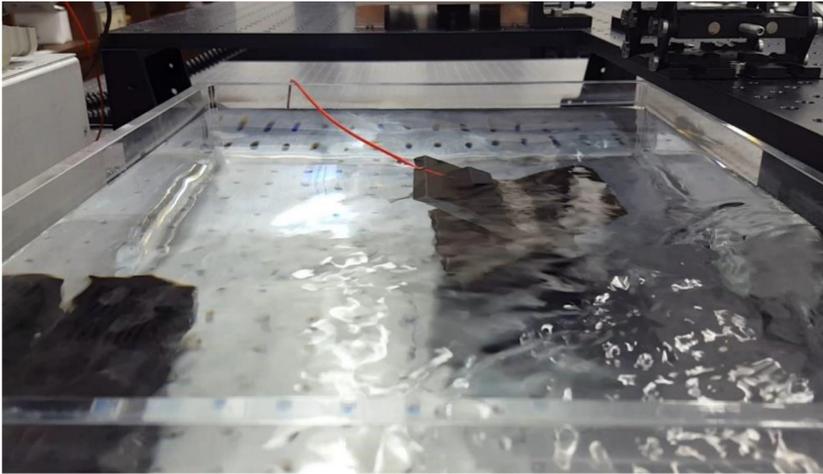
Figure 4: Random water oscillation caused by an aquarium filter.

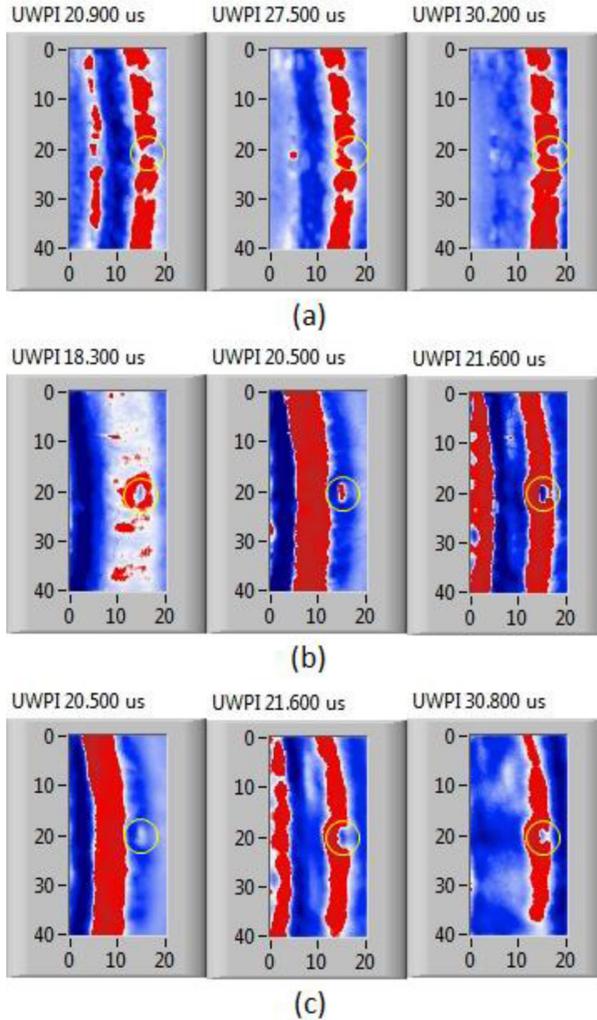
Figure 5: Ultrasonic wave propagation snapshot images, (a) free specimen, (b) submerged specimen without surface oscillation and (c) submerged specimen with surface oscillation.

is easy to estimate the crack size. The measured crack size in Fig. 5a and b is approximately 2 mm and 2.5 mm. The crack size is increased and the observed location is changed in submerged specimen case because the refracted laser beam is changed its interval length between laser pulses. Also, the signal with large amplitude is observed when the specimen is submerged. It's because the water roles as couplant for piezoelectric sensor so that the amplitude of the measured signal is increased.

For submerged specimen with water oscillation case, the crack is not detected very clearly and difficult to measure the size of the crack. The movie of wave propagation is diluted because the interval length of the laser pulse is irregular and affects to signal processing and the results. It's because irregular laser pulse intervals become regular when the repeated results are overlapped to get an average. The measured crack size of the submerged specimen with the water oscillation case is approximately 2.4 mm. Then compared with the case with the submerged specimen without water oscillation, the results are similar in size and location as shown in Fig. 5b and c.

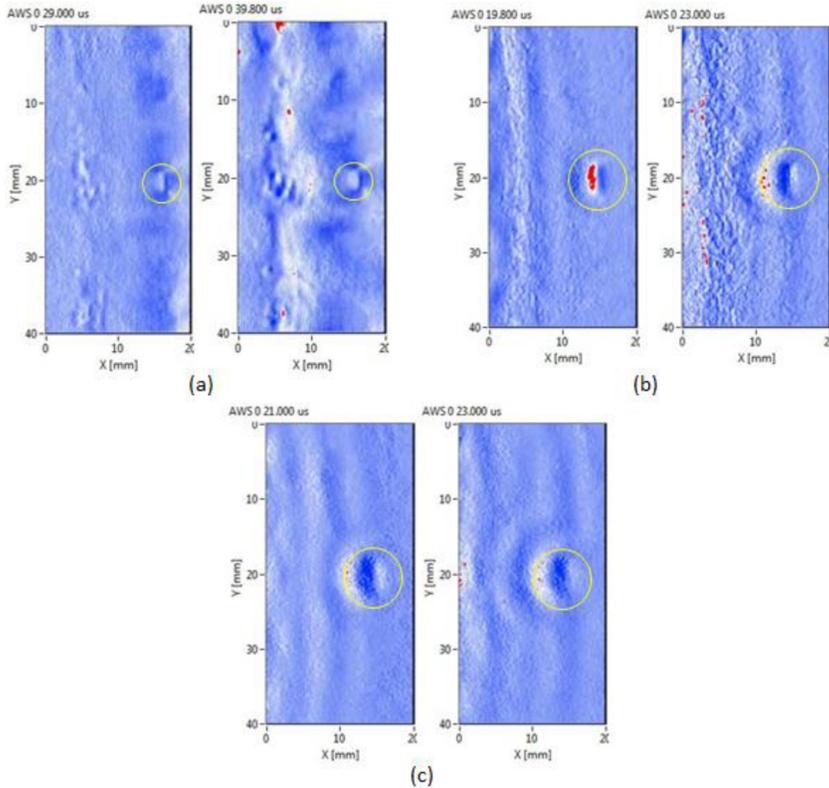
Figure 6: AWS algorithm results snapshot images, (a) free specimen, (b) submerged specimen without surface oscillation and (c) submerged specimen with surface oscillation.

Using the AWS algorithm, the crack damage can be easily detected because the scattering wave or reflected wave is observed clearly in AWS algorithm with 0 degree direction as shown in Fig. 6. In accordance with the results of ultrasonic wave propagation image, for both cases where the specimen is submerged in the water with or without surface oscillation, the measured crack size was bigger than the case where the specimen is outside of the water and the location also changed. For the result of submerged specimen with surface oscillation case, the AWS image is not as clear as that of the without surface oscillation case but the crack detection and the measurements are still possible. The crack is successfully detected in both ultrasonic wave propagation image algorithm and AWS algorithm showing the possibility of the ultrasonic propagation imaging system with repetitive scanning technique application for submerged structures even if the water surface is oscillated randomly.
