MANAGEMENT OF CHALLENGES DURING THE CONSTRUCTION OF OFFSHORE FACILITIES

OVE T. GUDMESTAD
University of Stavanger, Norway.

In this paper, we report on how the design and construction processes were adjusted during the construction phase of the largest of the North Sea platforms, the Troll offshore gas production facilities, as new information became available while the platform was in the construction phase.

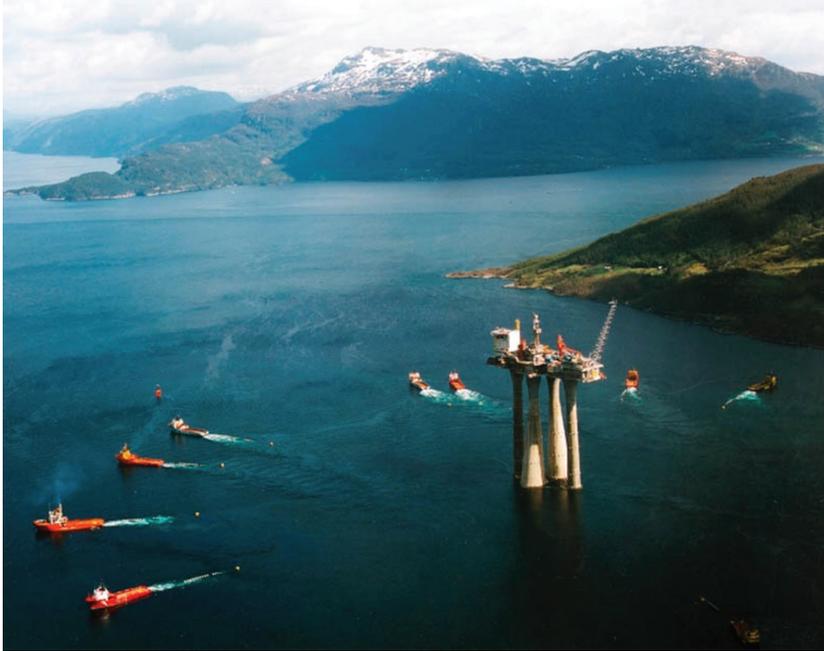
Figure 1: Towing the Troll concrete gravity platform to the offshore site throughout Norwegian fjords (Picture: Equinor/Statoil).

In parallel with the concrete platform construction, the steel deck and drilling/production facilities were finalized. All parts were then moved to a deep fjord near the Aker Stord construction yard for final mounting of the deck onto the concrete part and for commissioning of all facilities. Following the tow to the offshore site (Fig. 1), the fully operational platform immediately started to drill production wells and gas production started in September 1996.

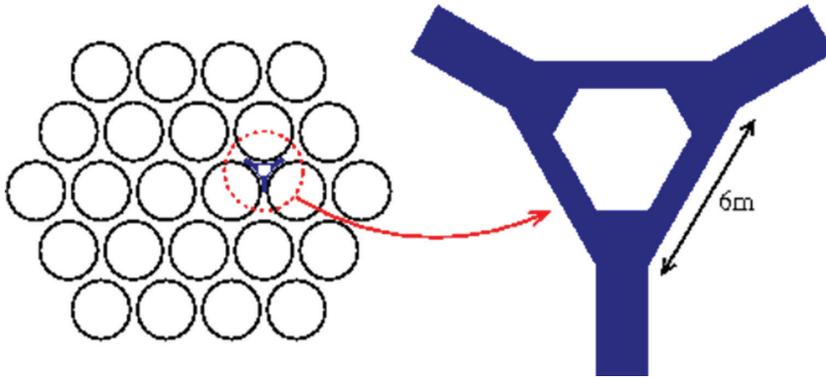
Figure 2: Failure in design of tri-cells of the Sleipner A platform.

The failure of the analysis led to 47% underestimation of shear stresses in a critical region and subsequently to insufficient reinforcement and insufficient anchorage of the reinforcement in the critical zone. As soon as the investigation was concluded, the construction of a second Sleipner A was started, this time, with sufficient reinforcement and with careful steel stirrups reinforcement keeping the rebars connected across the cross-section of the concrete wall in all critical sections of the platform.

- The concept report (the pre-engineering report) called for very thorough design reviews of critical areas of the foundation caisson where circular foundation cells were joined by triangular geometry cells, tri-cells. This was emphasised because there had been an incident with another concrete platform (Statfjord A) where leakages in these critical sections were observed.

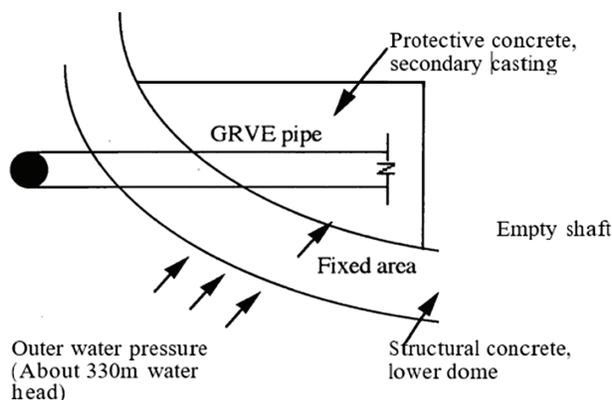
Figure 3: Section of the lower dome of the concrete platform, showing GRVE pipes and protective concrete [20].

In order to facilitate the ballasting operations, the installation at the field, and the ultimate removal of the platform from the site after the production period, ballast pipes were cast into the lower domes of the foundation cells and in the bottom of the columns. As the platform was initially designed for a 70-year life, it was decided early in the project to use pipes made of glass-fiber reinforced epoxy (GRVE), as some of these pipes (those for platform removal) had to be designed for the maximum life of the platform. GRVE would provide maximum corrosion resistance and was also thought to provide maximum safety during all project phases. For further protection, some of the pipes located in the bottom of the columns were protected against dropped objects with a concrete cover, Fig. 3.

Late in the construction phase it became evident that there could be a risk of pipe leakage due to the possibility of clipping the 2" and 8" glass-fiber reinforced composite pipes in the riser and utility columns (the outer edge columns) of the concrete platform during submergence testing and deck transfer. Clipping would result from movement between the structural

concrete in the lower domes and the non-structural protective concrete above. Eventually, the clipping could result in loss of the platform due to rapid flooding of these shafts, causing the platform to sink. At this time, the loss of Sleipner A during the submergence phases was fresh in the mind of all involved in the project. The probability of clipping with resulting leakage of one or several of the 8 inches GRVE pipes in the concrete platform was estimated to be 2.6×10^{-1} as calculated using the PROBAN software [20]. The failure probability of each individual GRVE pipe was defined as the probability that the local clipping displacement each pipe was exposed to was larger than the clipping capacity for this pipe.
